School Safety Study for Schroeder Middle, Valley Middle, and South Point Elementary Schools

Final Report

February 2013

Prepared for:
Grand Forks – East Grand Forks Metropolitan
Planning Organization

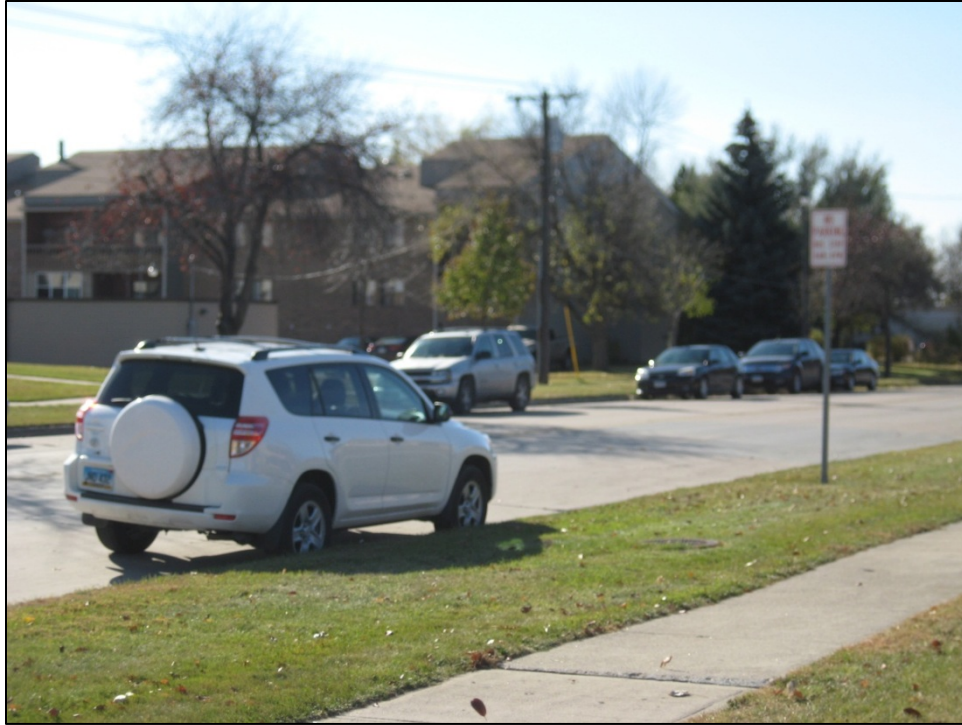
Almost half an hour prior to dismissal, despite the parking restrictions, vehicles were observed stopped on both north and south side of the street along 32nd Ave S as shown in figures 4.1 and 4.2 below. Also, during the same time, vehicles were observed stopped on both east and west sides of S 10th St as shown in figure 4.3 below.

Figure 4.1 Vehicles stopped/parked along 32nd Ave S prior to dismissal

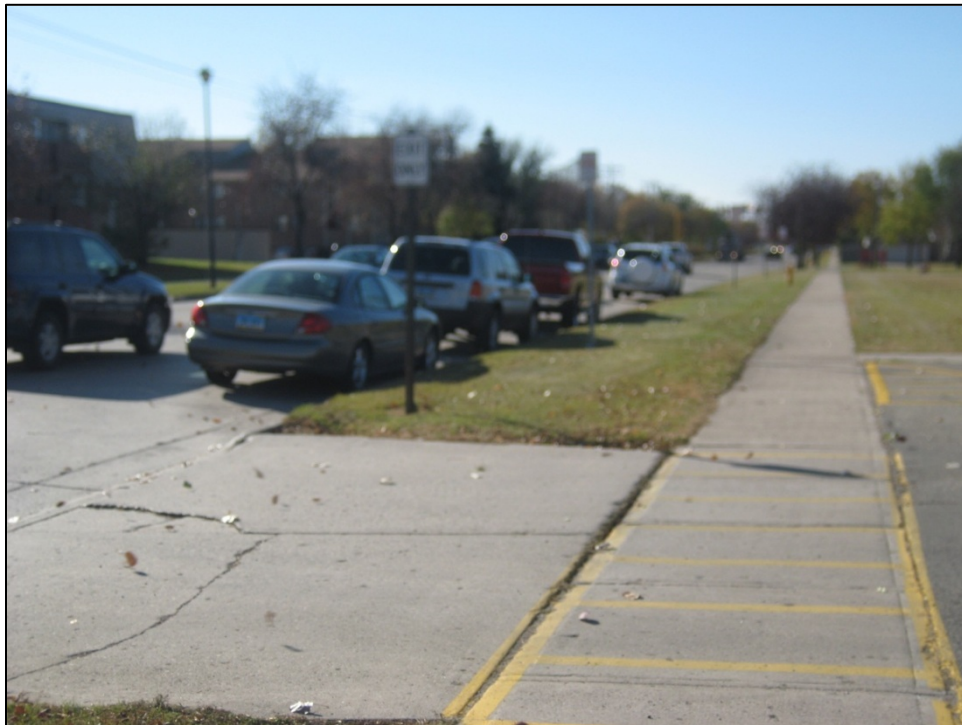
Figure 4.2 Additional vehicles stopped/parked along 32nd Ave S prior to dismissal

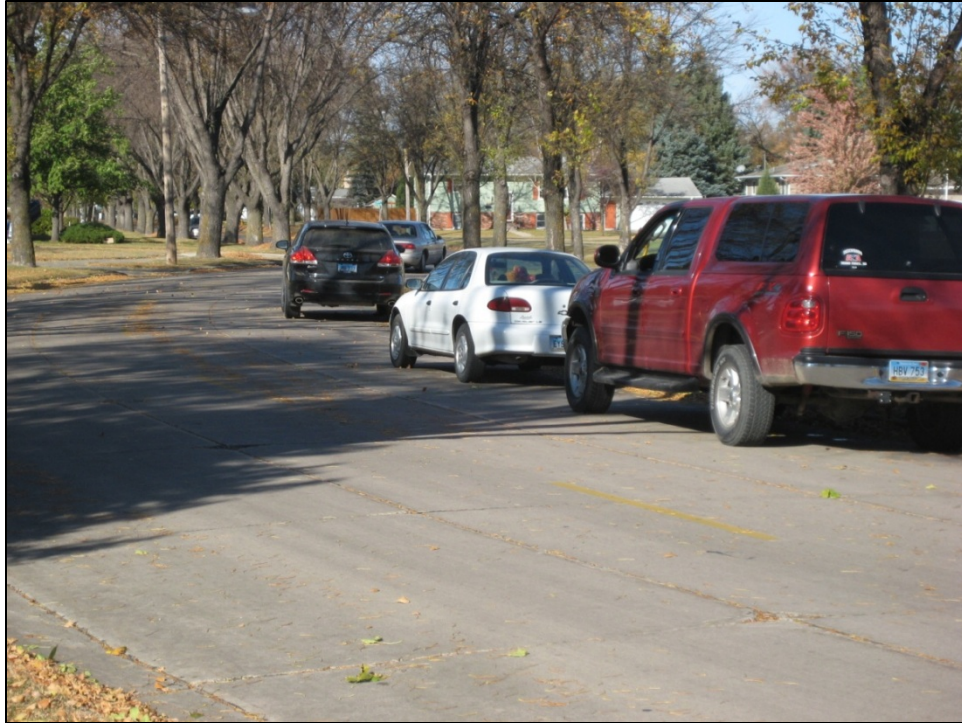
Figure 4.3 Vehicles stopped/parked along S 10th St prior to dismissal

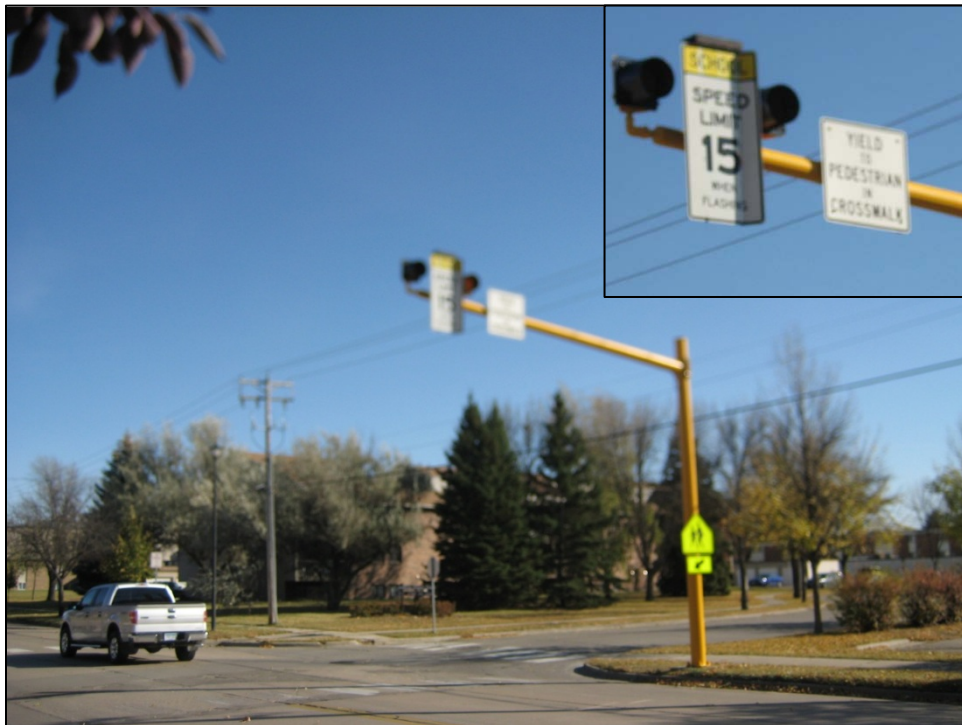
The pedestrian flashing beacons were working properly and vehicles were observed reducing speeds, yielding to pedestrians, and proceeding with caution through the intersection of 32nd Ave S and S 10th St. However, the speed limit sign (on the eastbound approach malfunctioned) and also the pavement markings were worn out as shown in figure 4.4 below.

Figure 4.4 Worn out pedestrian crossing and malfunctioning speed limit sign (inset)

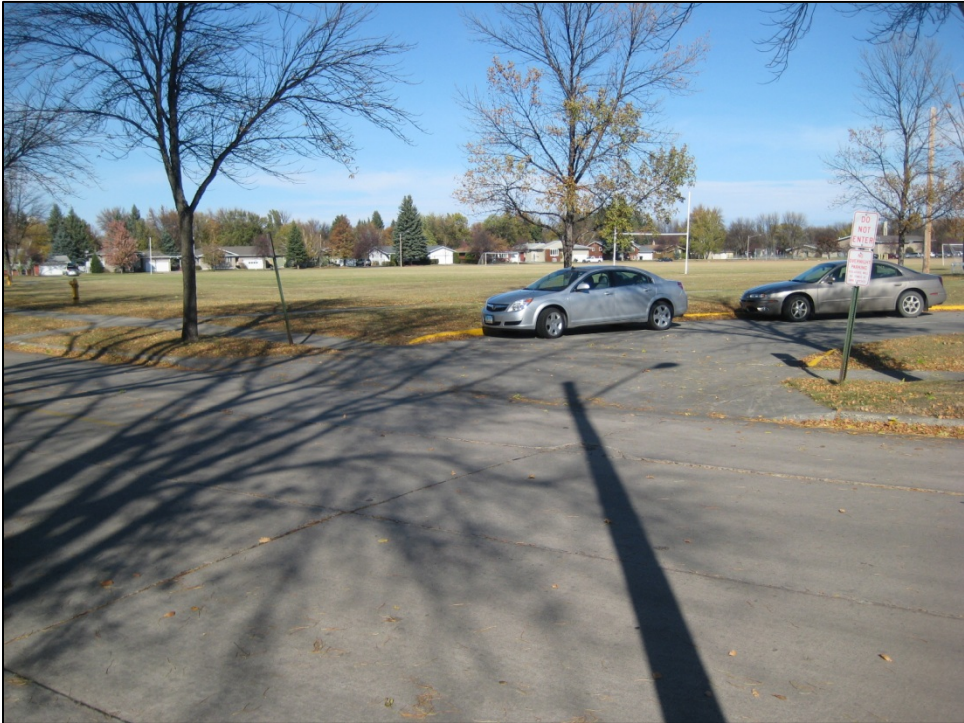
Figure 4.6 Vehicles parked in the driveway of the west parking lot

Given the fact that the west parking lot does not have a lot of spaces, it was not surprising to see it full, as shown in figure 4.5 above. However, vehicles were seen stopped/parked in the driveways and other non-designated areas of the lot as shown in figure 4.6 above.

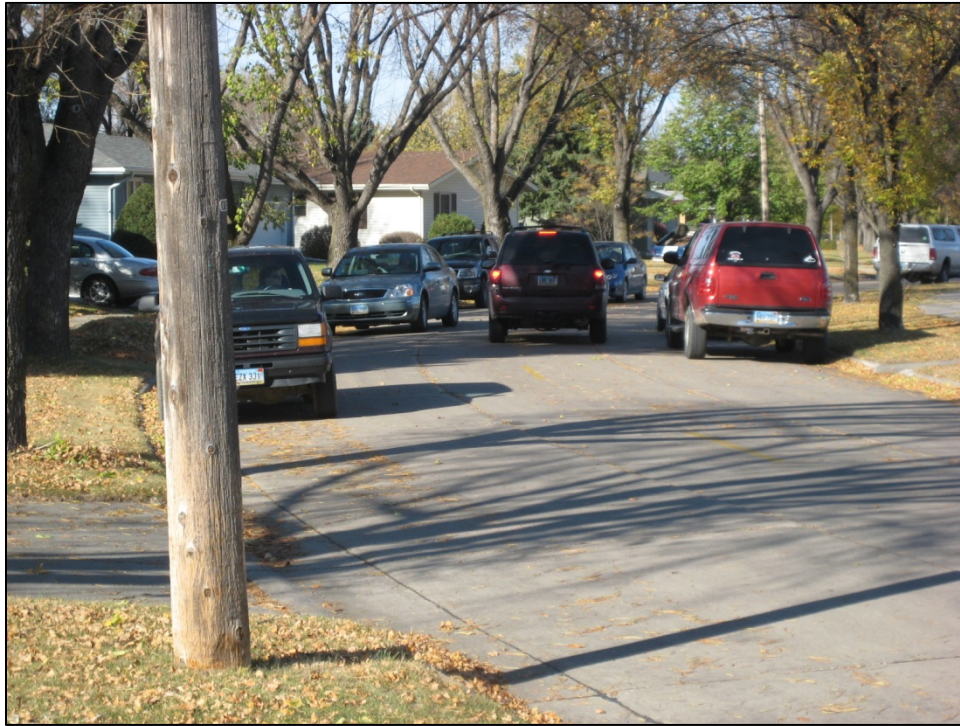
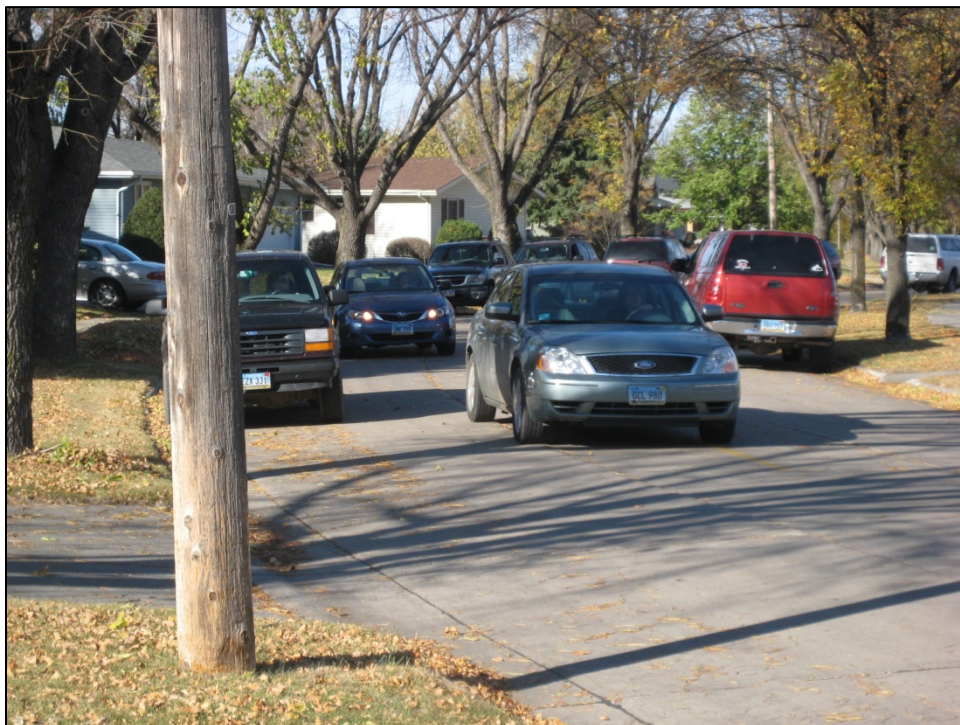
Figure 4.7 Vehicles stopped/parked on both sides of S 10th St

Figure 4.8 More vehicles stopped/parked on both sides of S 10th St

Vehicles parked on both sides of S 10th St caused capacity reduction to the point that only one vehicle could pass through as is evident from figures 4.7 and 4.8 above. Students were observed running across the parking lot as well as the streets to reach their parents' vehicles. Pedestrian safety was reduced not only by vehicles being parked on both sides of S 10th St but also by vehicles parked in non-designated areas in the west parking lot. It was observed that the vehicles entering/exiting the parking lot were going at a high rate of speed. The vehicles speeding through the parking lot combined with students/pedestrians becoming 'invisible' while walking between parked cars created a potentially very dangerous situation.

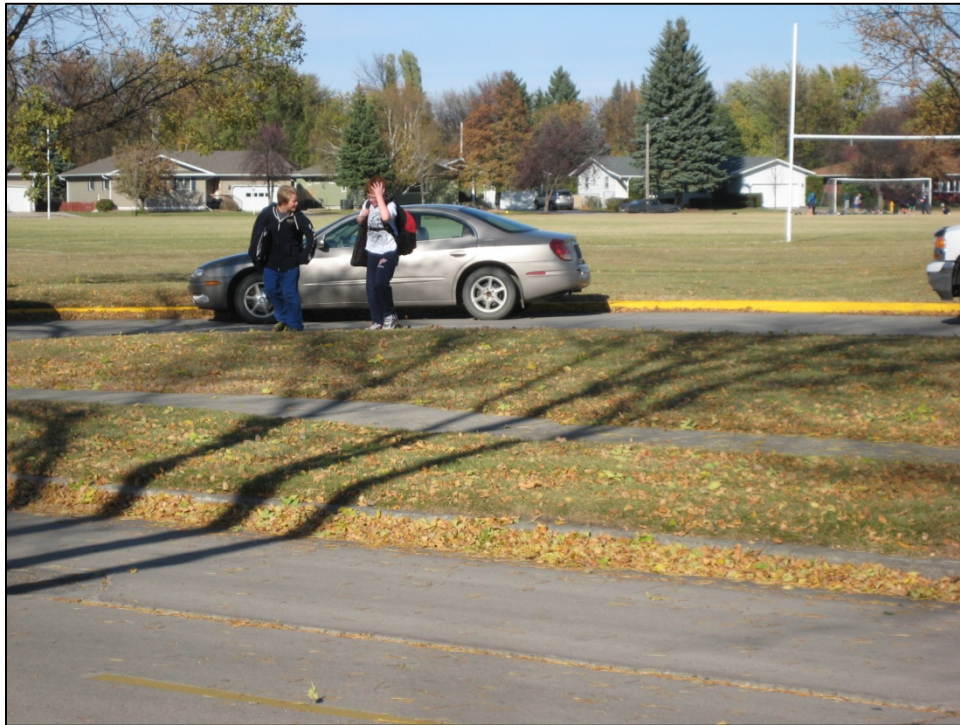
Figure 4.9 Vehicles stopped/parked at undesigned areas and students crossing midblock

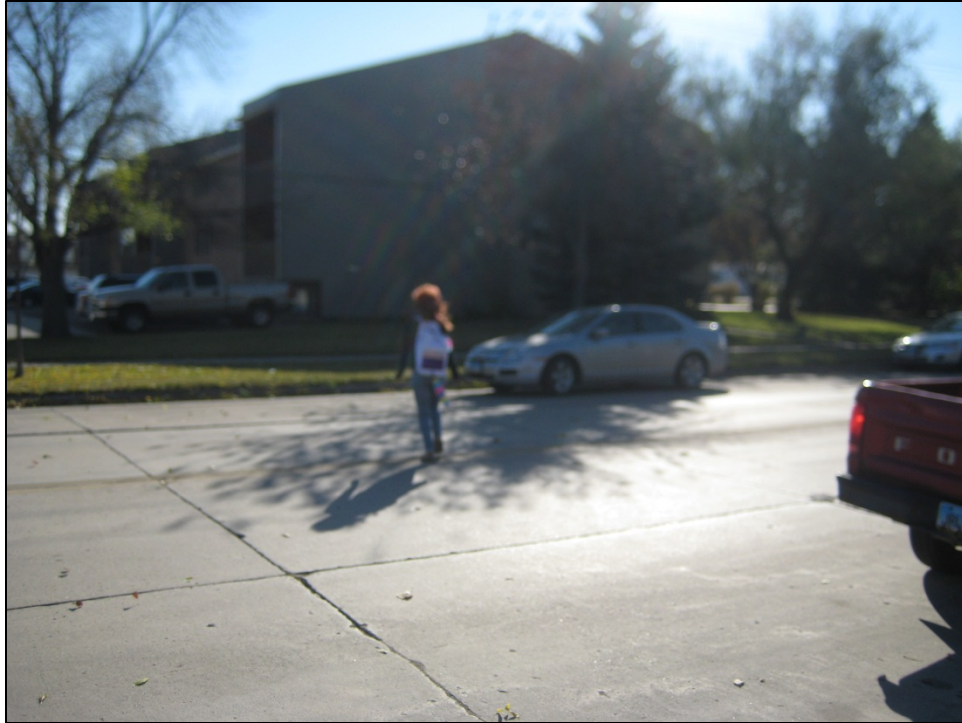
Students were seen crossing 32nd Ave S midblock, as seen in figure 4.10 below. Midblock crossing or jaywalking is a safety issue. Also, students were observed running across the street as can be seen in figure 4.11 below. It is unsafe for pedestrians to run across the street even on marked crosswalk locations. In some cases, parents were seen jaywalking along with the kids. Some parents were seen waving to the kids to encourage them to cross the street midblock. Also, students were observed waiting between parked cars to cross the street midblock as seen in figure 4.12 below. This is another safety concern as the driver's vision being blocked by the illegally parked vehicle; he/she may not be able to see the student waiting to cross or vice versa.

Figure 4.10 Student crossing midblock on 32nd Ave S

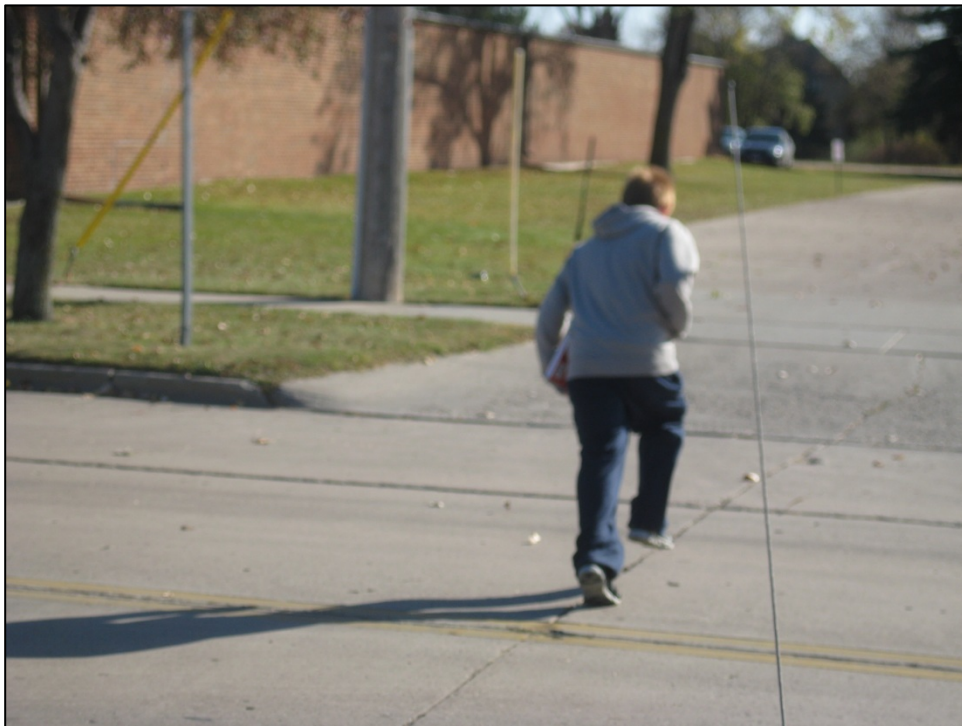
Figure 4.11 Student running across the street on 32nd Ave S

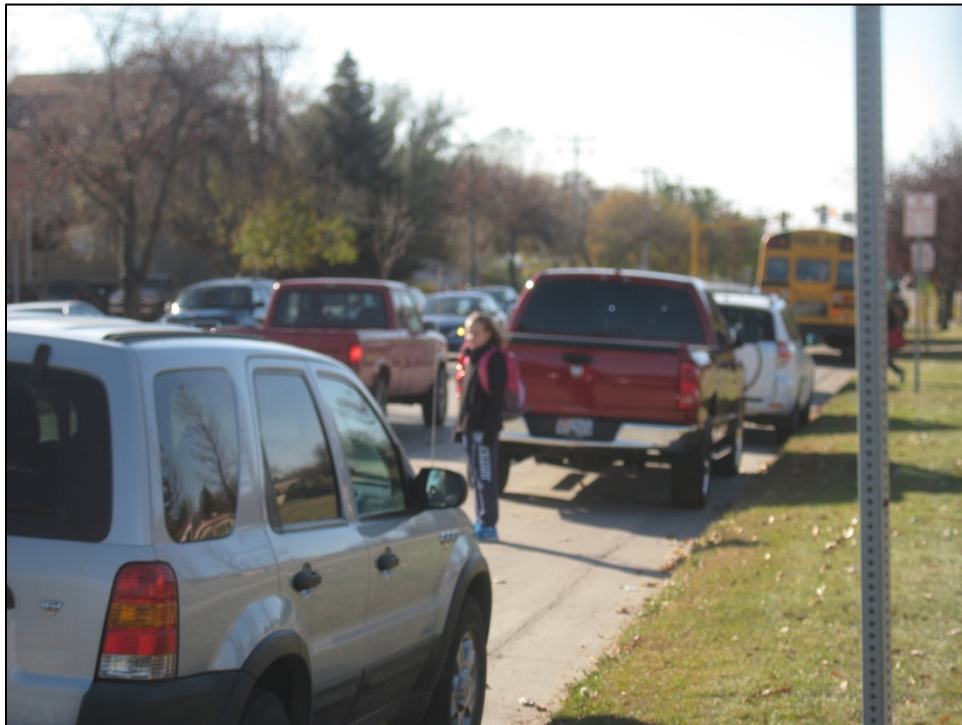
Figure 4.13 Student waiting between parked vehicles to cross the street on 32nd Ave S

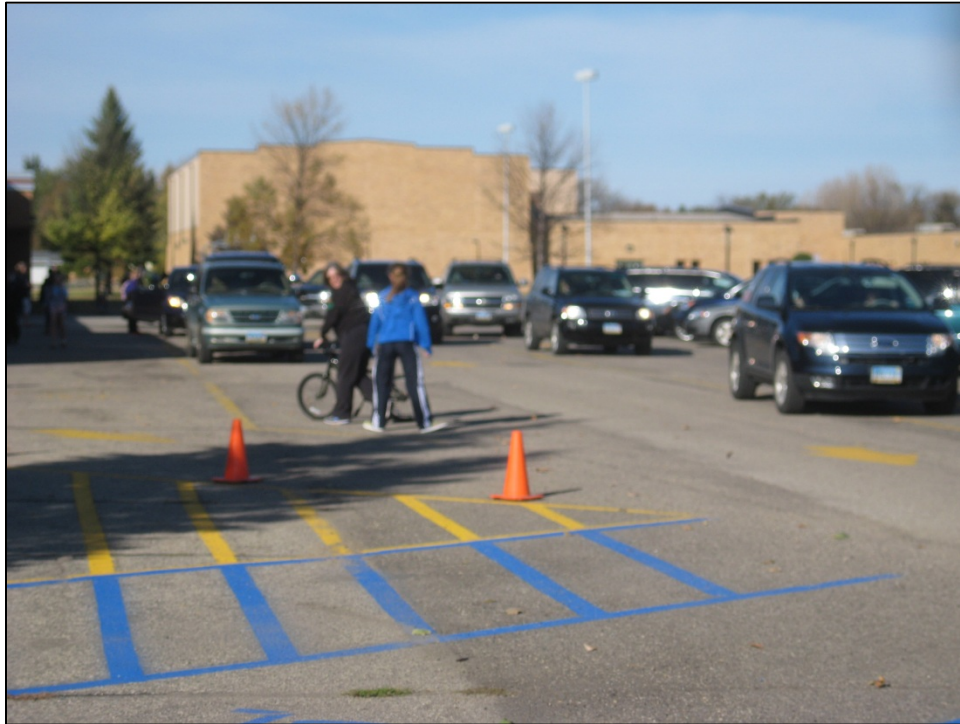
Students were observed running across the parking lot (south-east lot). Also, students were observed riding their bike in the parking lot as seen in figure 4.14 below. Also, prior to dismissal, a bike was observed parked at an undesignated location in front of the school as seen in figure 4.15 below.

Figure 4.14 Student riding bike inside the south-east parking lot

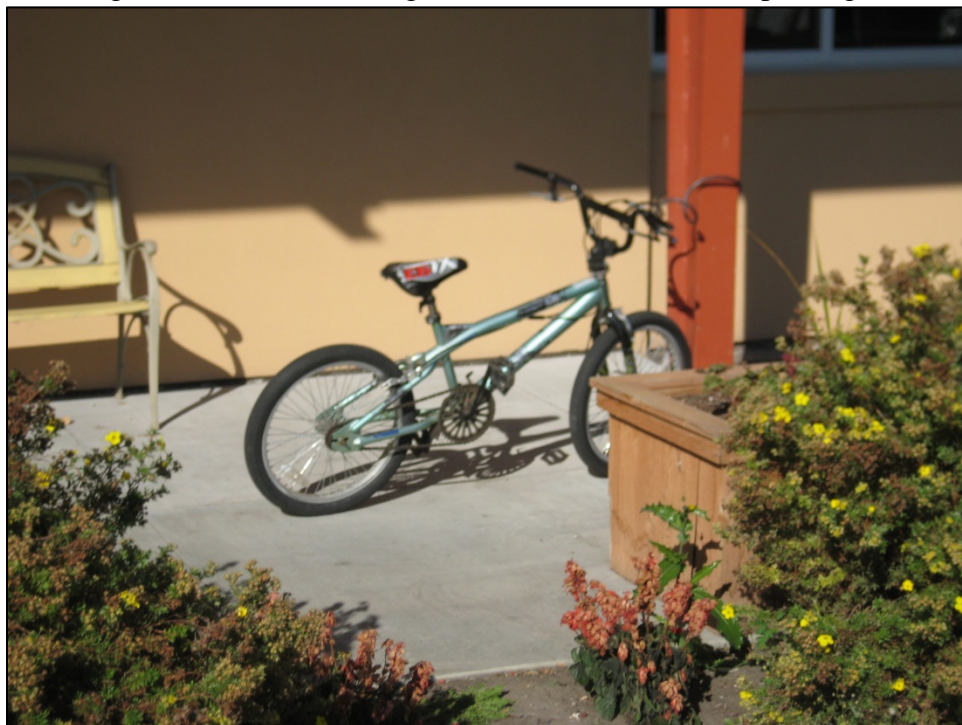
Figure 4.15 Bike parked at undesignated spot

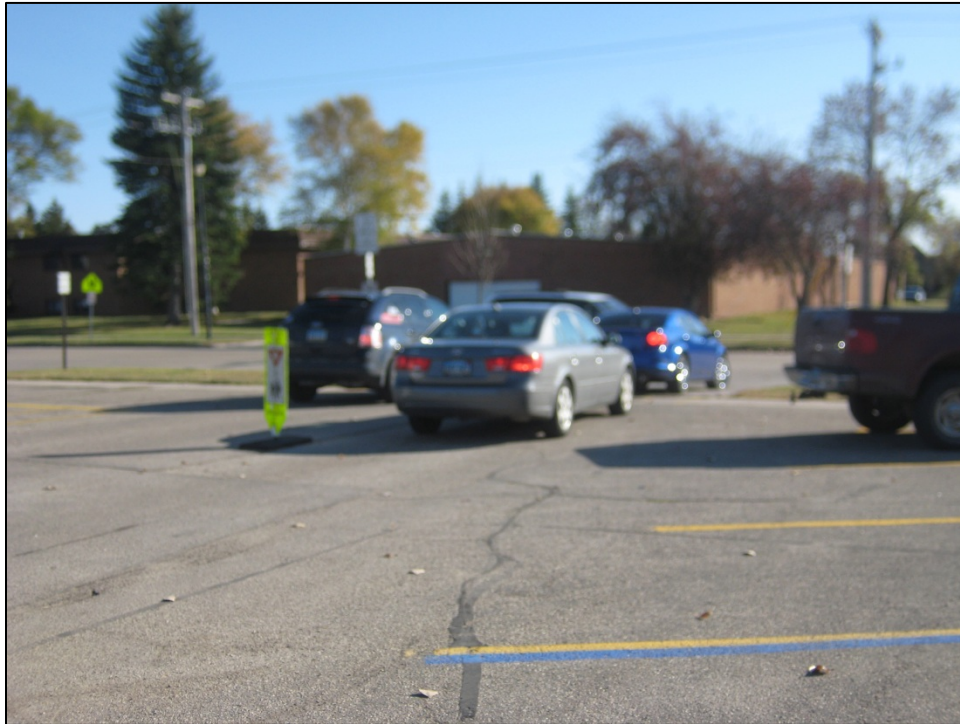
It was observed that vehicles exiting the south-east parking lot formed two lanes at the end of the driveway as shown in figure 4.16 below. This not only caused confusion among drivers but also traffic conflicts. In addition, it could potentially interfere with drivers pulling out of the accessible parking spaces.

Figure 4.16 Vehicles forming two lanes while exiting the south-east parking lot

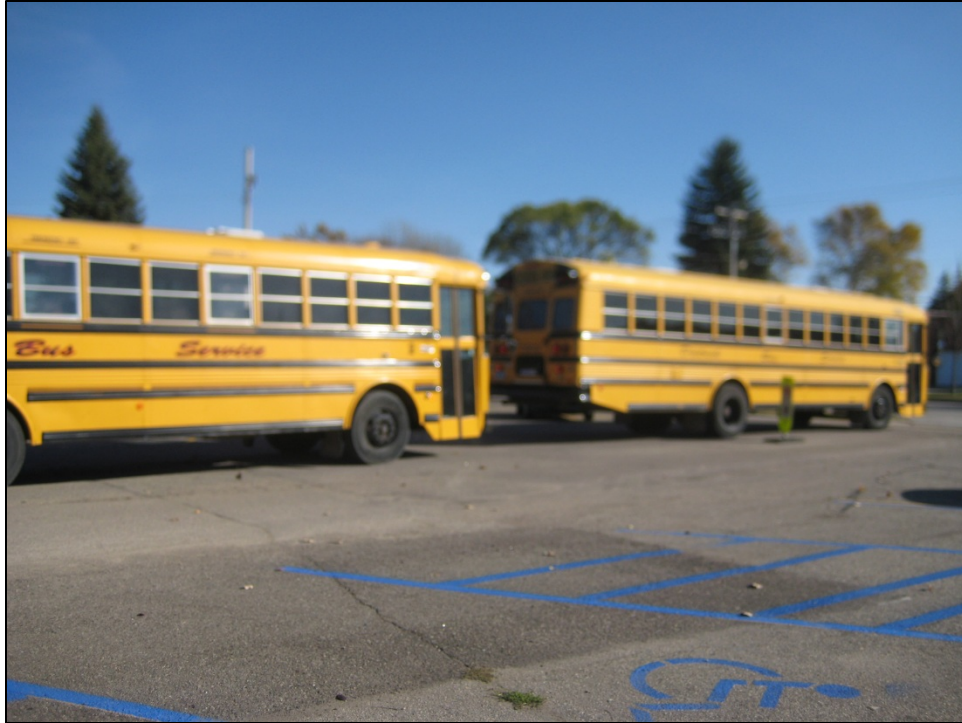
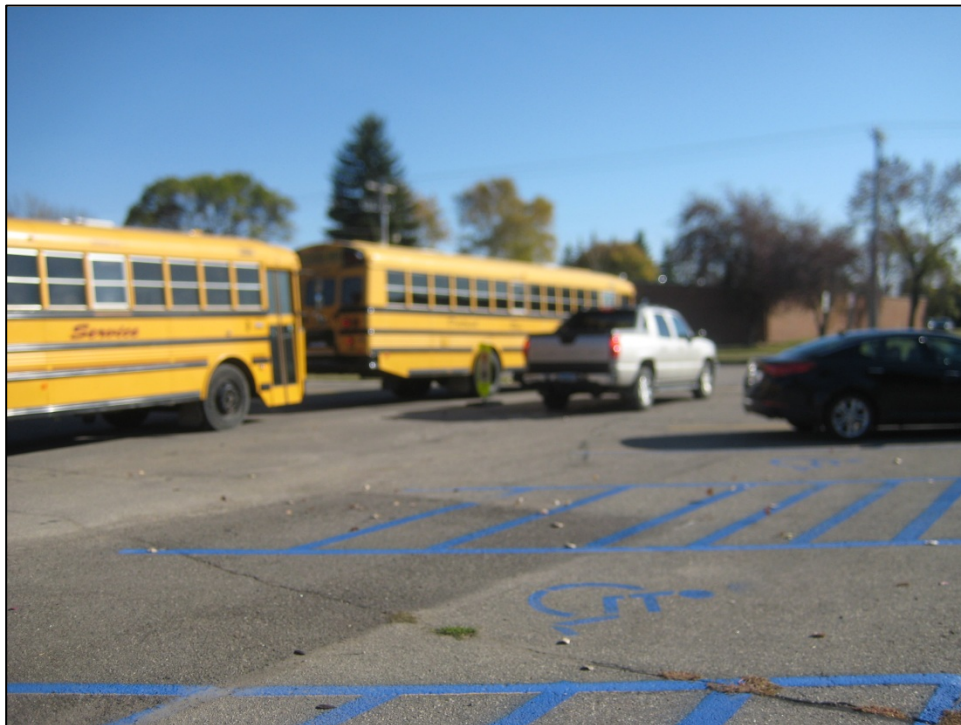
The parent funded buses were first seen pulling into the south-east parking lot to make a U-turn and then make a right turn going out of the driveway to park in their designated spots as expected. However, disregard was observed on parents' part as they exited the driveway while the buses were waiting to turn right as seen in figures 4.17 and 4.18 below.

Bus operations, in terms of making a right turn out of the parking lot, were also hampered by the vehicles parked in the no parking zone on the north side of 32nd Ave S. The buses had to make an even wider right turn after waiting for a gap where both directions of lanes were clear.

Figure 4.17 Buses waiting to make a right turn on to westbound 32nd Ave S

Figure 4.18 Parents passing the bus on the right

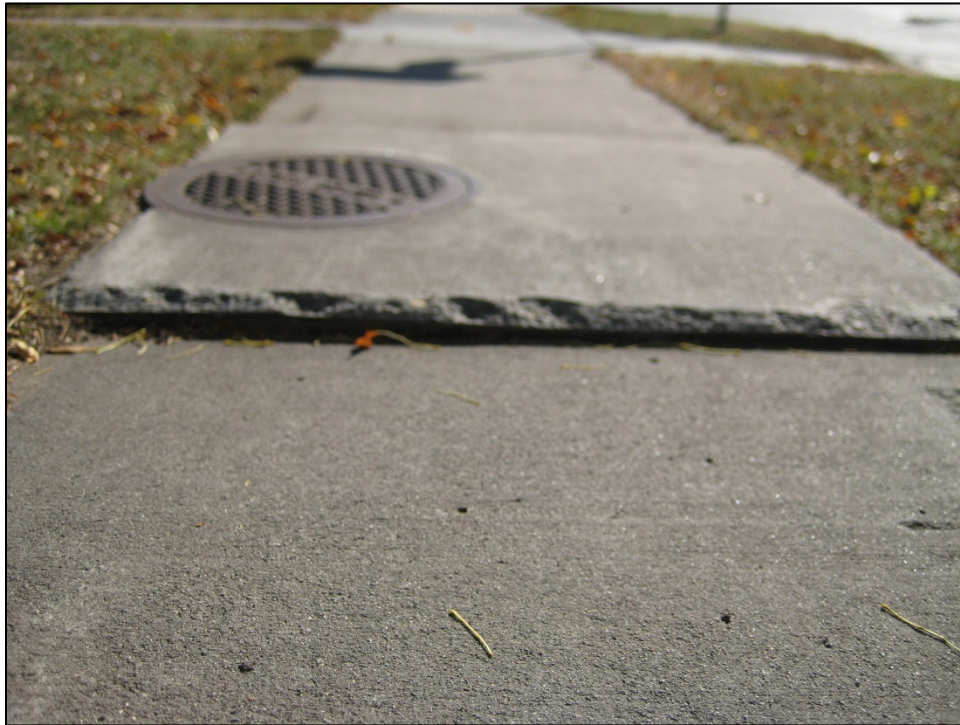
In addition to the concerns noted above, faulting was observed in the slabs at some sidewalk locations as shown in figure 4.19 below. It presents a safety hazard.

Figure 4.19 Faulted slab in sidewalk on the west side of the school

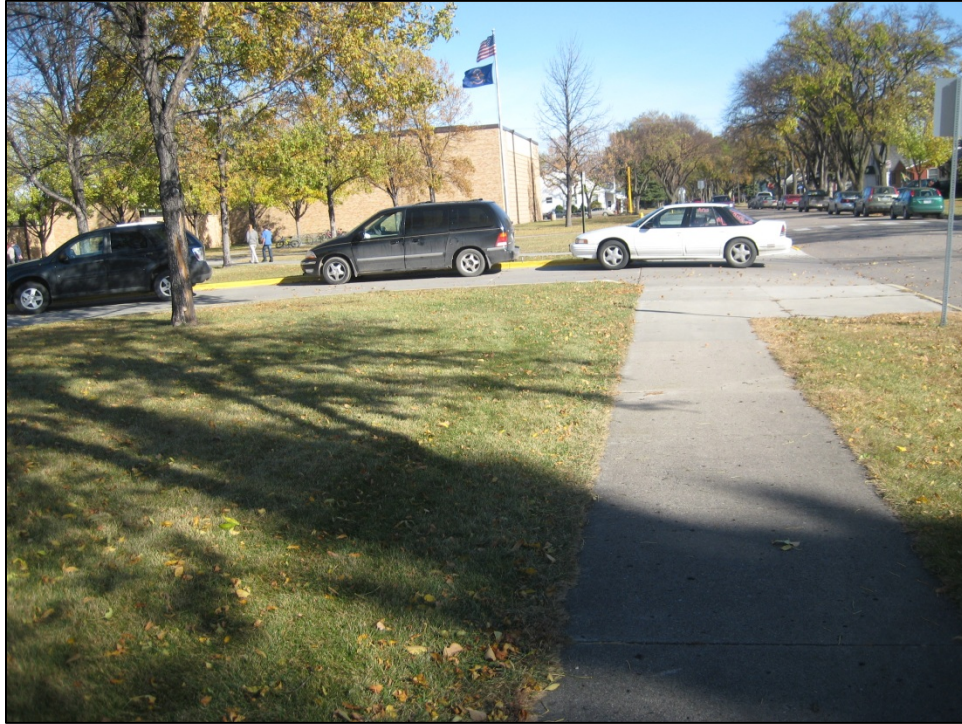
Prior to dismissal, vehicles were observed parked along both sides of 5th Ave N and also the nearby residential streets. Some vehicles were seen parked in the driveways leading in and out of the south parking lot as seen in figure 4.20 below.

Figure 4.20 Vehicles parked in the driveway of south parking lot prior to dismissal

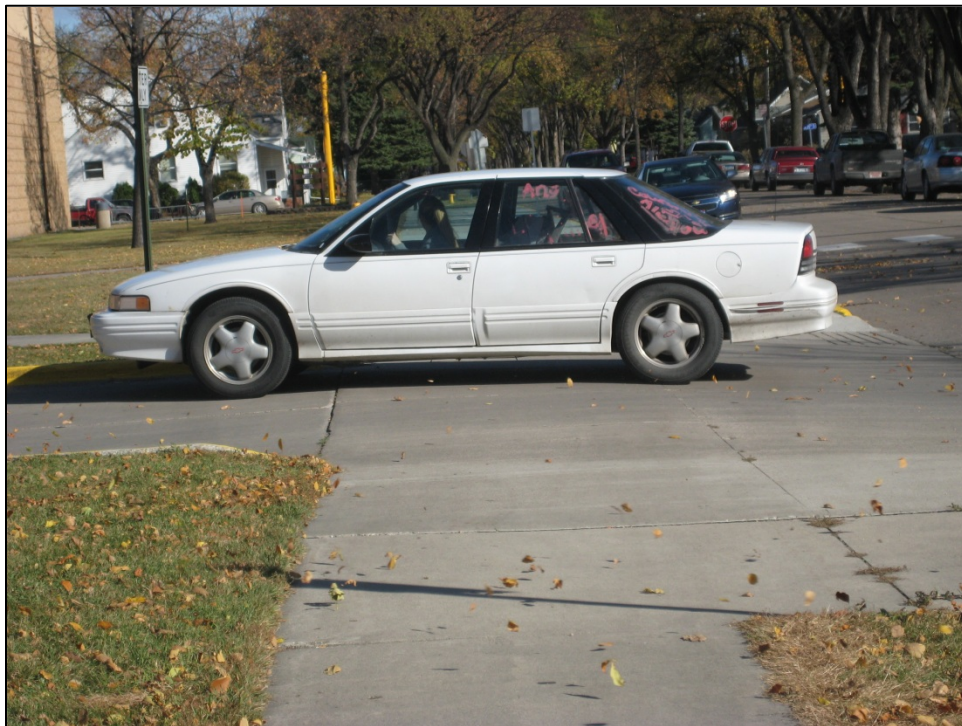
Figure 4.21 Vehicle blocking sidewalk

Some vehicles were also observed blocking the sidewalk as can be clearly seen in figure 4.21 above.

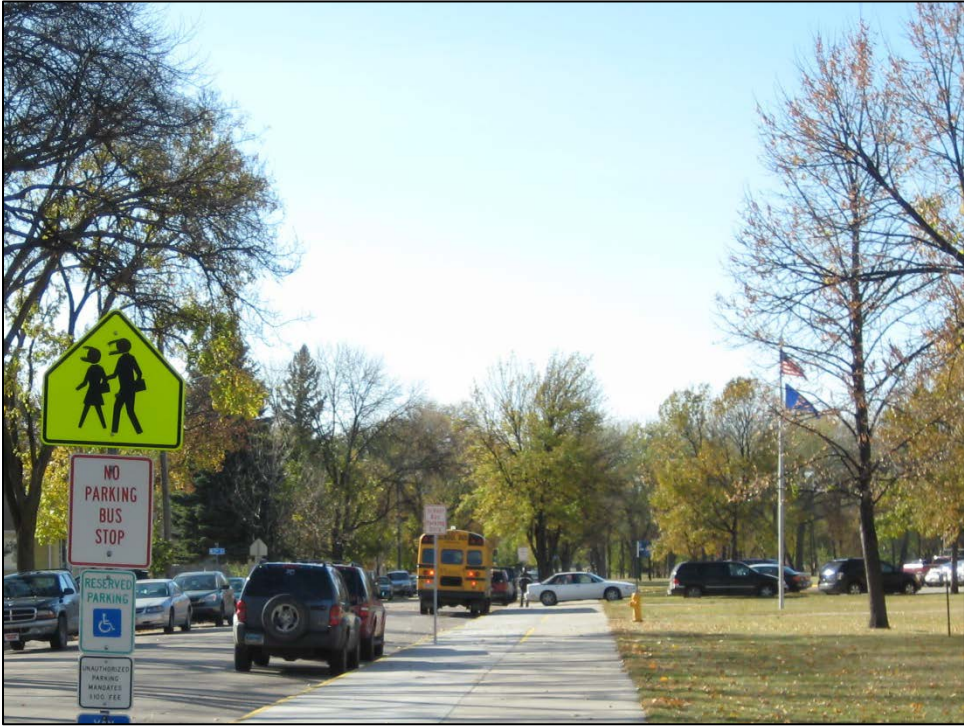
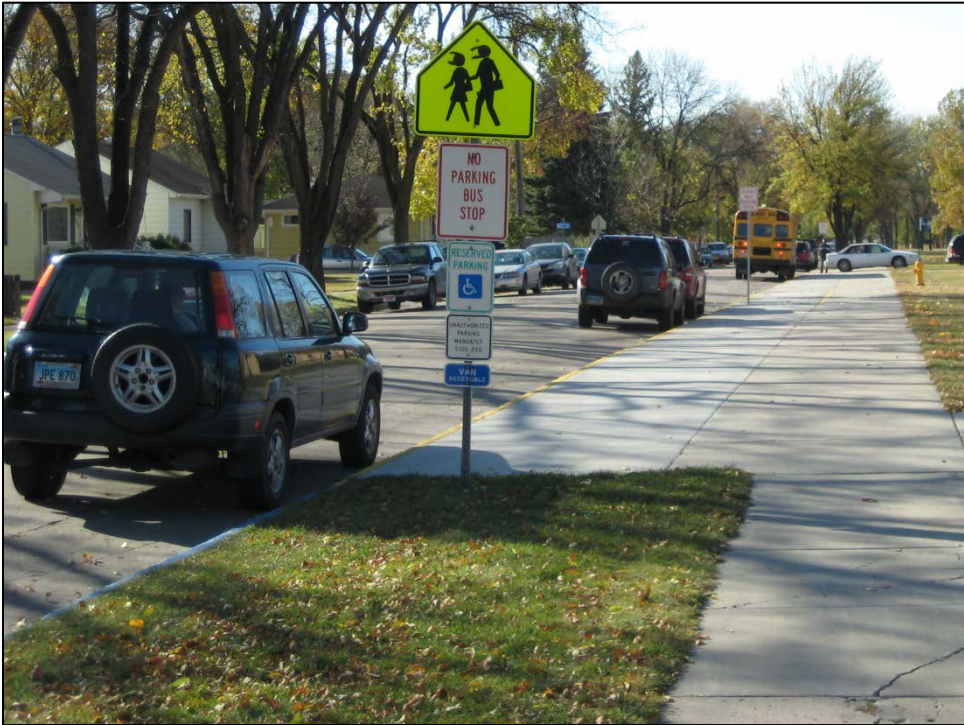
Figure 4.22 Vehicles parked in spot reserved for school bus

Figure 4.23 Vehicle violating multiple parking related ordinances

It was further observed that vehicles parked in the spots reserved exclusively for school buses as seen in figures 4.22 and 4.23 above. Also, vehicles with no relevant parking permit were observed parked in accessible parking spots as can be seen in figure 4.23 and 4.24.

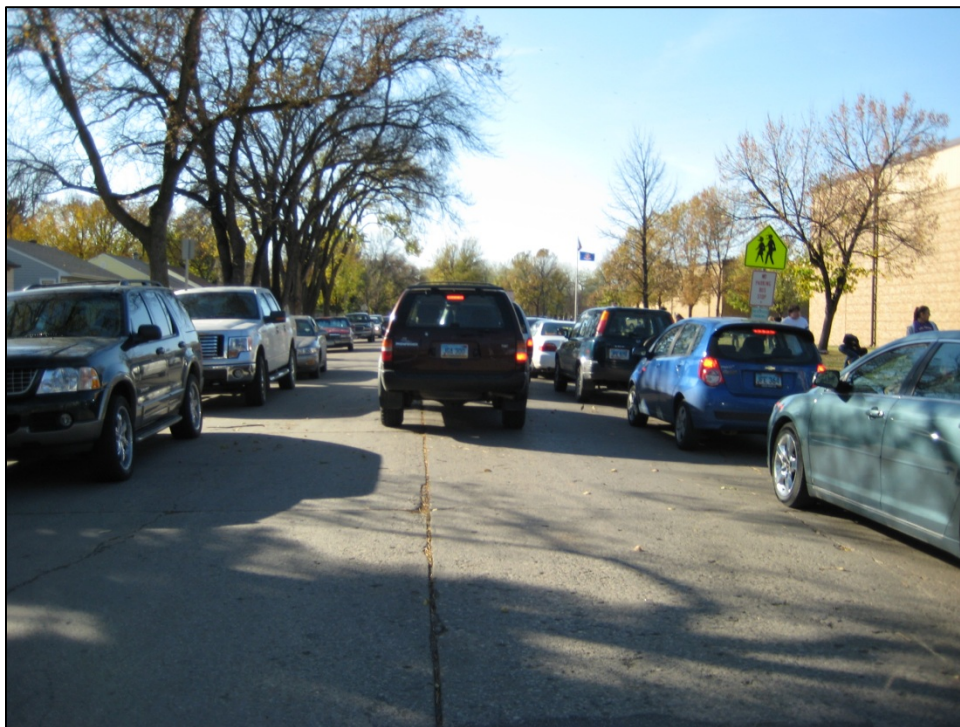
Additional vehicles were seen double parking along already illegally parked vehicles along 5th Ave N as seen in figure 4.24 below. This not only blocked traffic but also presented potential blockages for emergency vehicles, especially bigger vehicles such as fire trucks.

Figure 4.24 Double parking along 5th Ave N

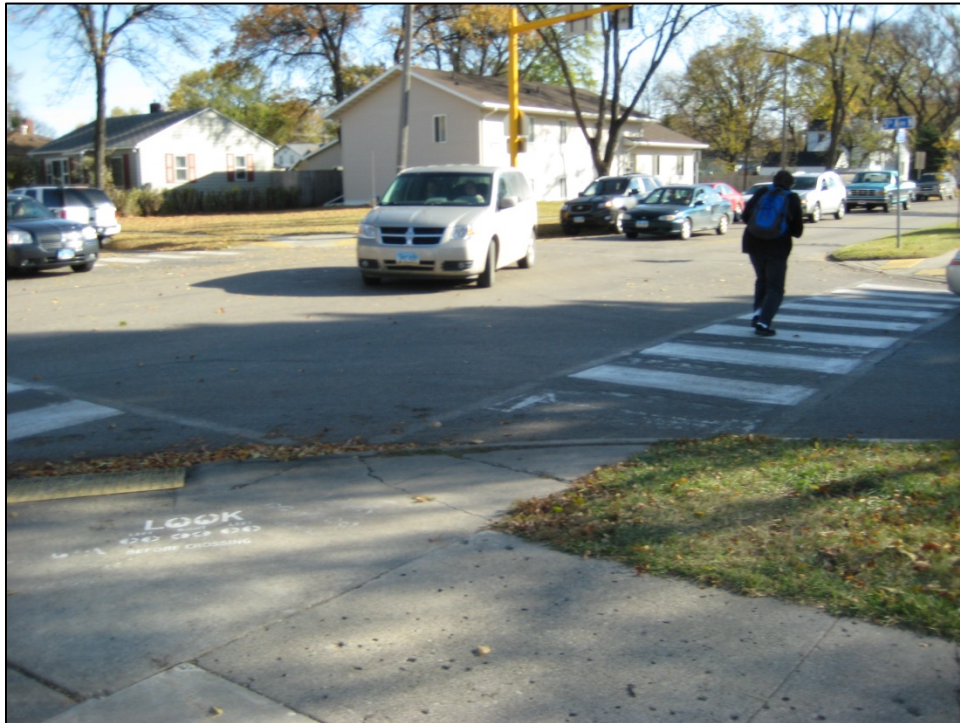
Some students were observed crossing the streets midblock or crossing at the crosswalk in an unsafe manner as seen in figures 4.26 and 4.28. It was observed that some students rode their bikes on the crosswalk or even ran across the street.

Figure 4.28 Student running across the street while crossing at the crosswalk

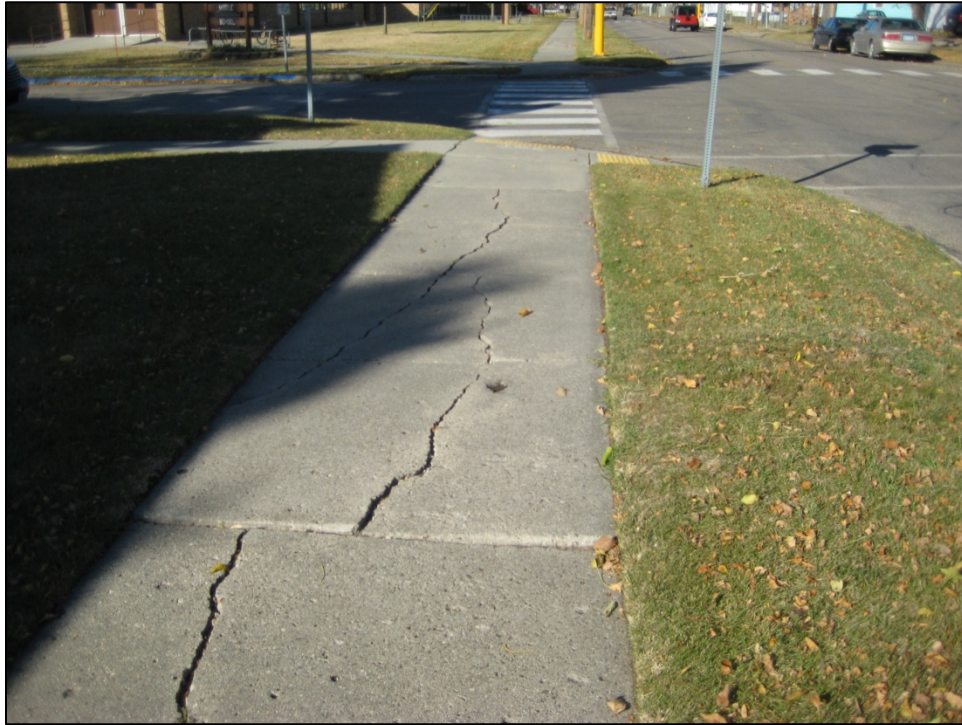
At certain locations along N 20th St, the sidewalk slabs showed signs of failure and longitudinal and fatigue cracking was observed as seen in figure 4.29 below.

Figure 4.29 Longitudinal cracking in sidewalk slabs along S 20th St

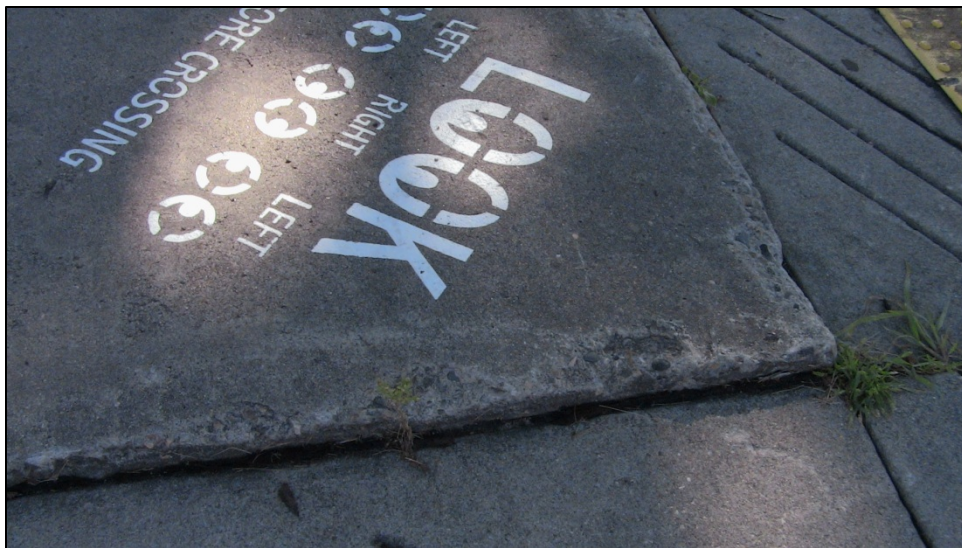
Figure 4.30 Faulting near crosswalk at the intersection of S 20th St and 5th Ave N

Figure 4.30 above shows faulting near crosswalk at the intersection of S 20th St and 5th Ave N. This is a safety concern for pedestrians and mobility concern for disabled users and must be remedied.

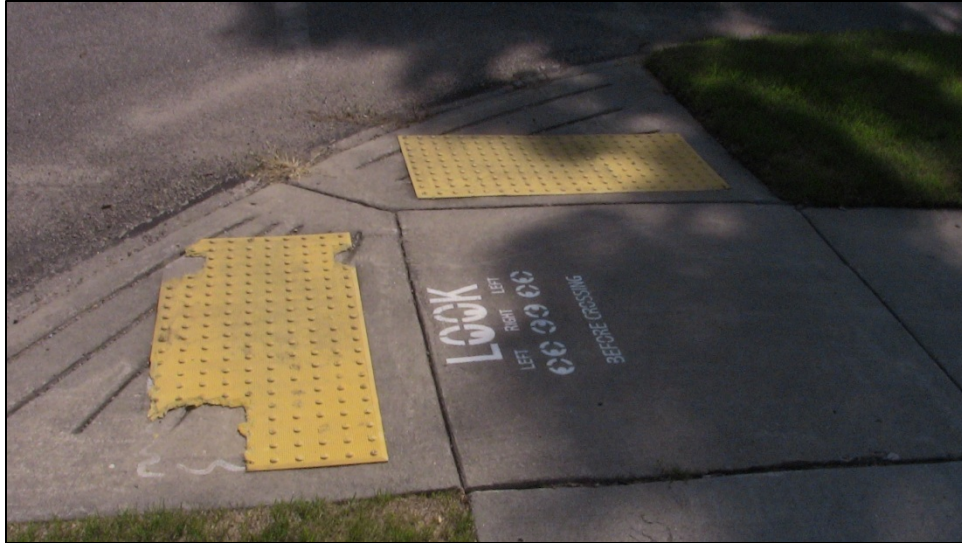
Figure 4.31 Damaged truncated domes

Also at the same intersection, damaged truncated domes were observed at the crosswalk locations as can be seen in figure 4.31 above. Poor drainage was also observed as can be seen in figure 4.32 below. This is especially unsafe for pedestrians and motorcycles.

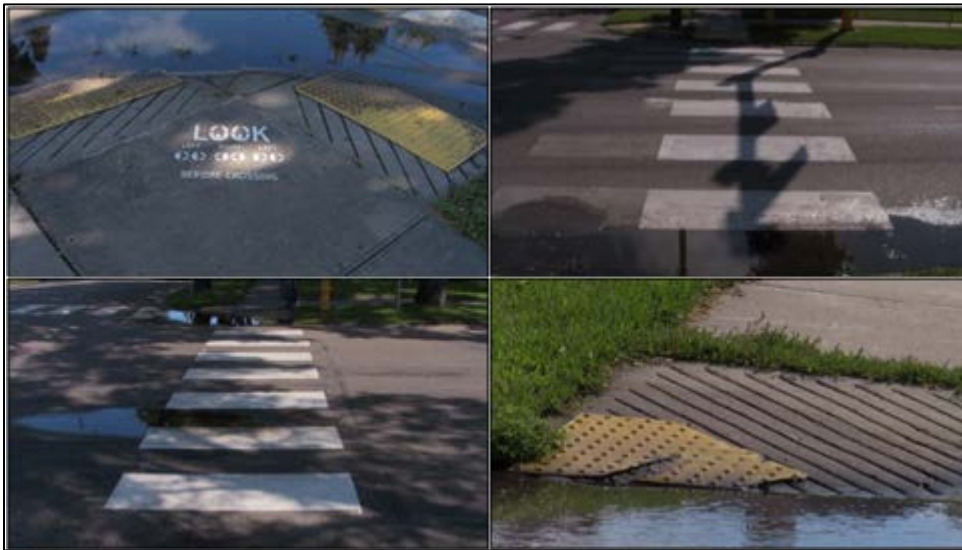
Figure 4.32 Poor drainage conditions and damaged truncated domes at S 20th St and 5th Ave N

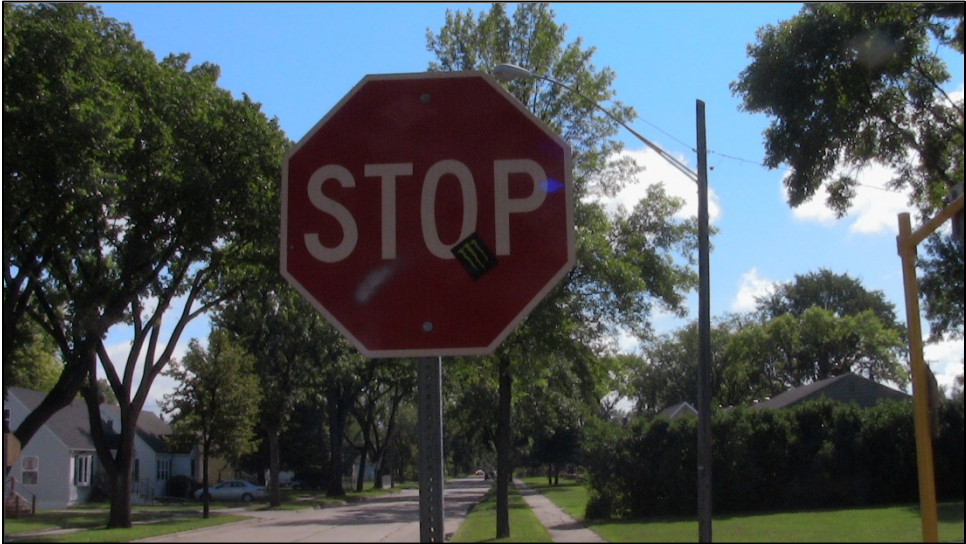
Graffiti was observed on various signs around the school as seen in figures 4.33, 4.34, and 4.35 below.

Figure 4.33 Graffiti on a stop sign at the intersection of S 20th St and 5th Ave N

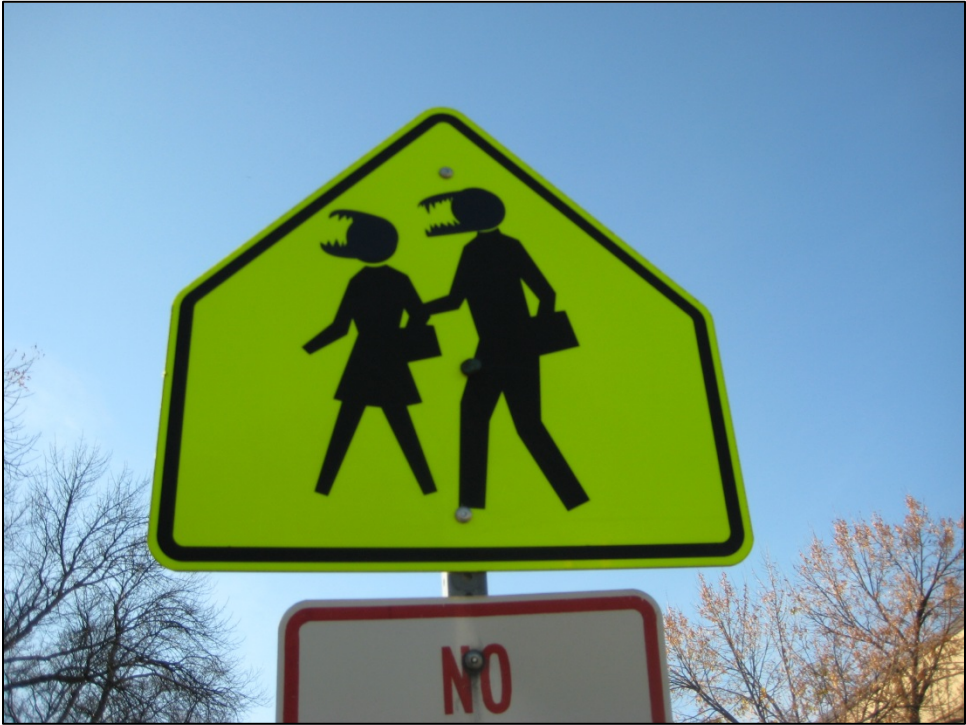
Figure 4.34 Graffiti on a school crossing sign along 5th Ave N

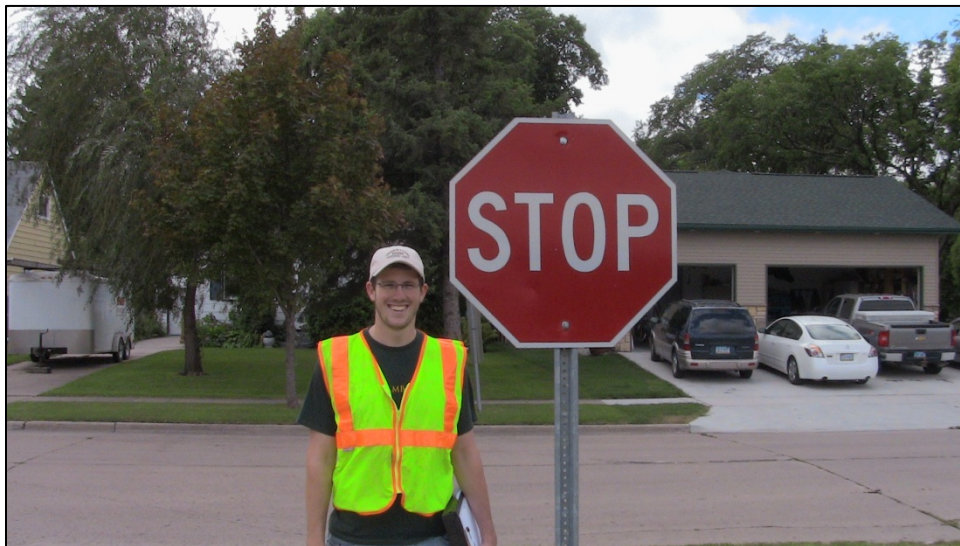
The stop sign for traffic exiting the south parking lot is installed at an inappropriate height. It is much lower as can be seen in figure 4.36 below.

Figure 4.36 Inappropriate height of stop sign

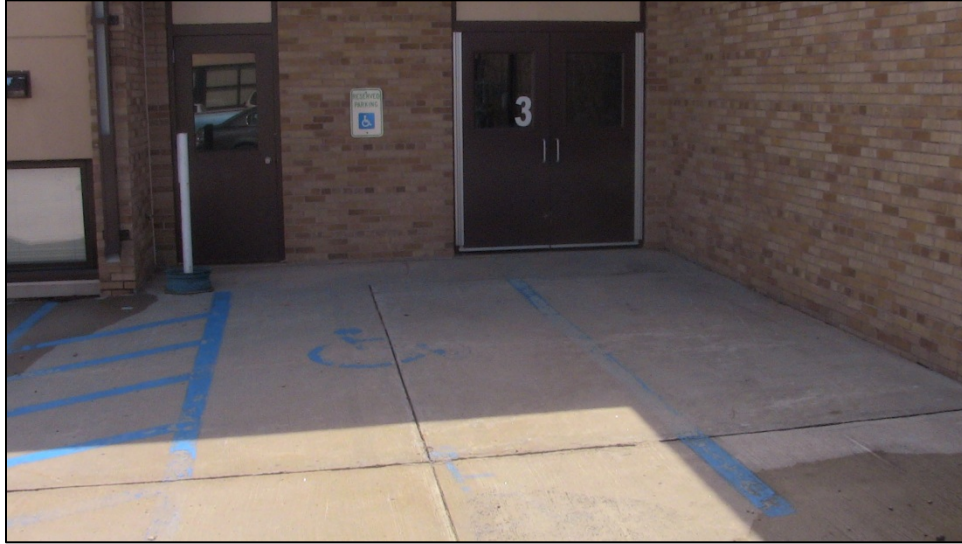
Many parking spots in the north-east parking lot were found to be blocking the doors. These were mainly accessible spaces. However, vehicles parked in those spaces would inadvertently block the exits as can be clearly seen in figures 4.37 and 4.38 below.

Figure 4.37 Accessible parking space blocking two doors in the north-east parking lot
