School Safety Study for Schroeder Middle, Valley Middle, and South Point Elementary Schools

Final Report

February 2013

Prepared for:
Grand Forks – East Grand Forks Metropolitan
Planning Organization

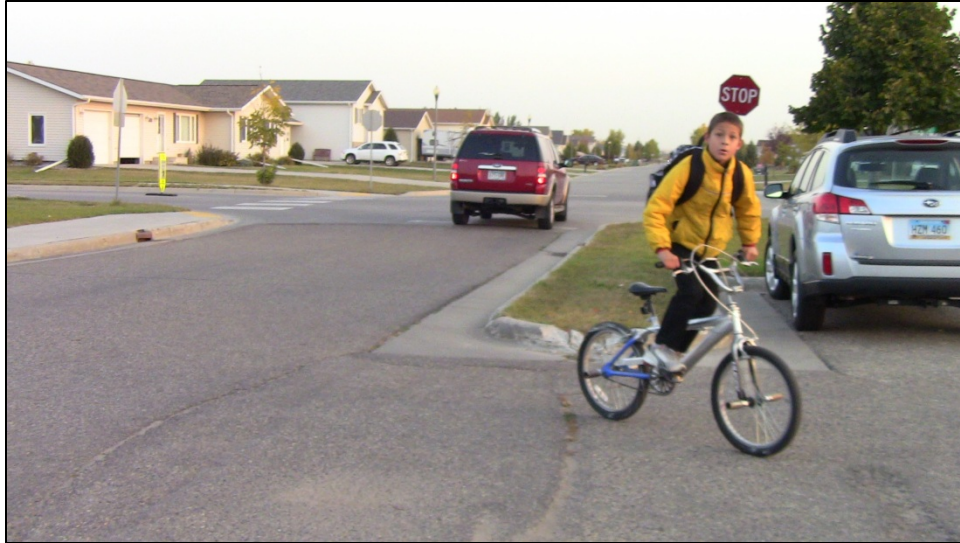
However, most of the students biking to school were seen doing it in an unsafe manner. Students were seen cutting across the driveway without paying attention to oncoming traffic or vehicles that may be following them closely as can be seen in figure 4.43 below. Also, most of the students doing so were not wearing any protective gear leaving them vulnerable and more prone to injuries in case of a crash.

Figure 4.43 Student biking across the driveway in an unsafe manner.

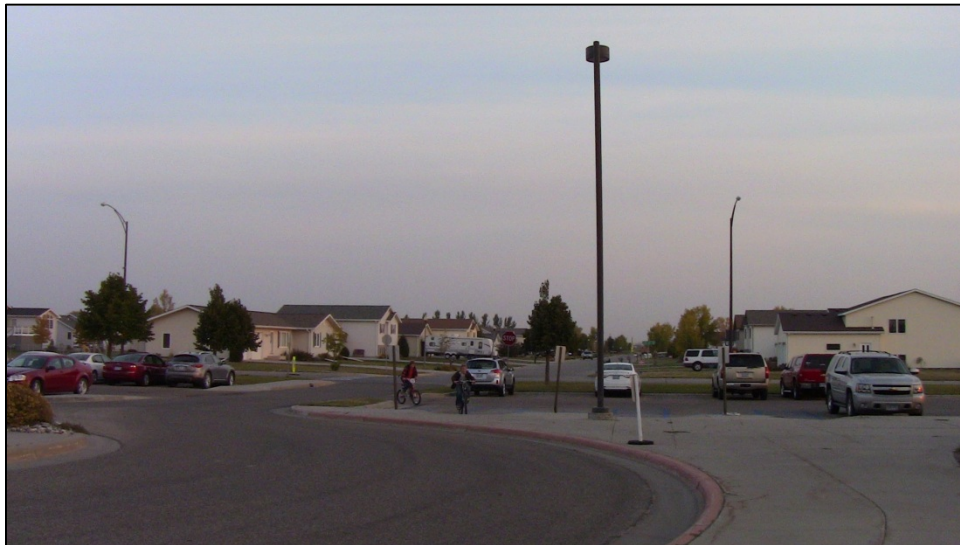
The students cutting across the driveway then proceeded through the parking lot. They cut across accessible parking spaces and ramps meant for wheelchairs towards the bike rack located in the north-east of the main entrance of the school as seen in figures 4.44 thru 4.46 below. These students were also noted to be cutting across the driveways/parking lot spaces at a high rate of speed.

Figure 4.44 Students biking across the driveway and parking lot spaces in an unsafe manner.

Although not clear from the above picture, but none of the students were wearing protective gear.

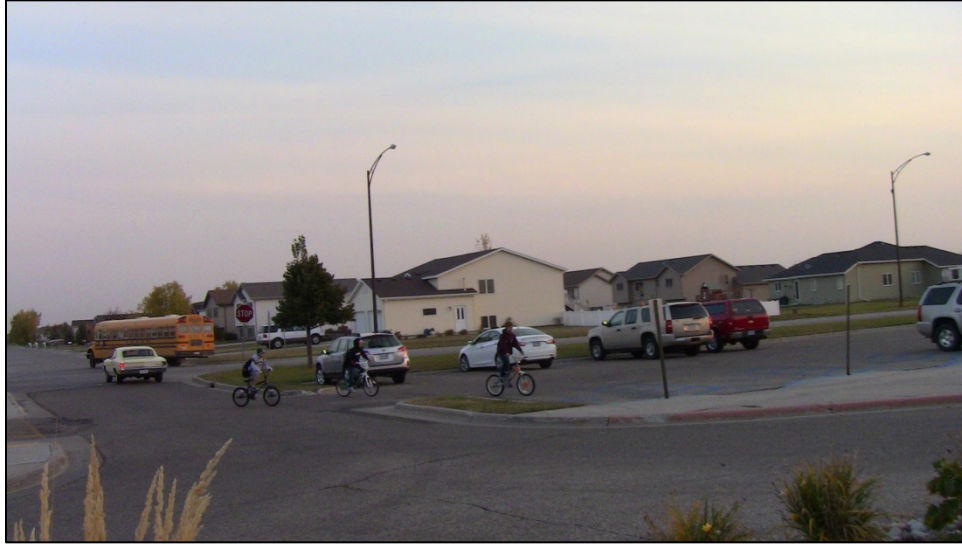
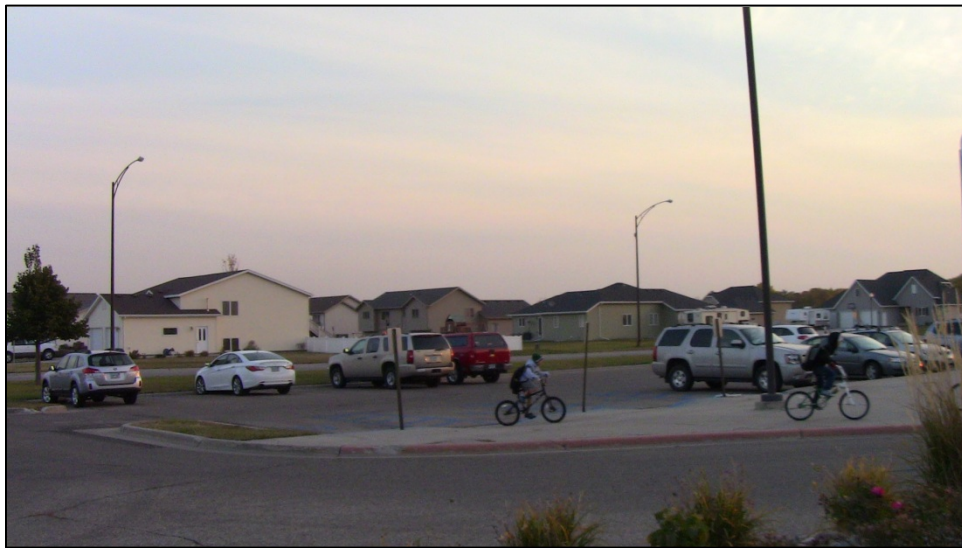
Figure 4.45 A group of students biking across the driveway

Figure 4.46 The same group of students biking across the parking lot at a high rate of speed

Note that none of the students in figures above were wearing protective gear.

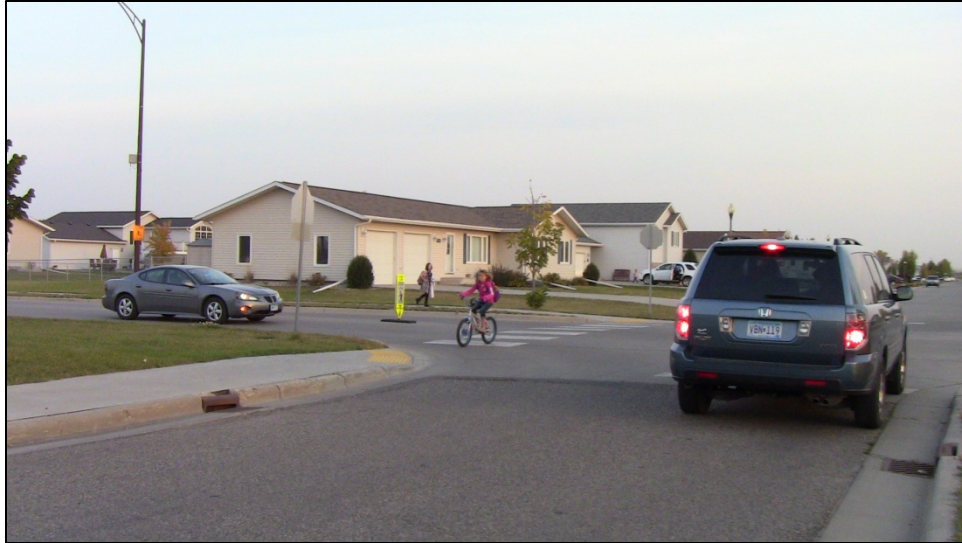
In addition, a number of students were seen riding their bikes on the streets adjoining the school in an unsafe manner. For example, kids were seen riding their bike on the crosswalk as seen in figure 4.47 below.

Figure 4.47 Student riding their bike on crosswalk

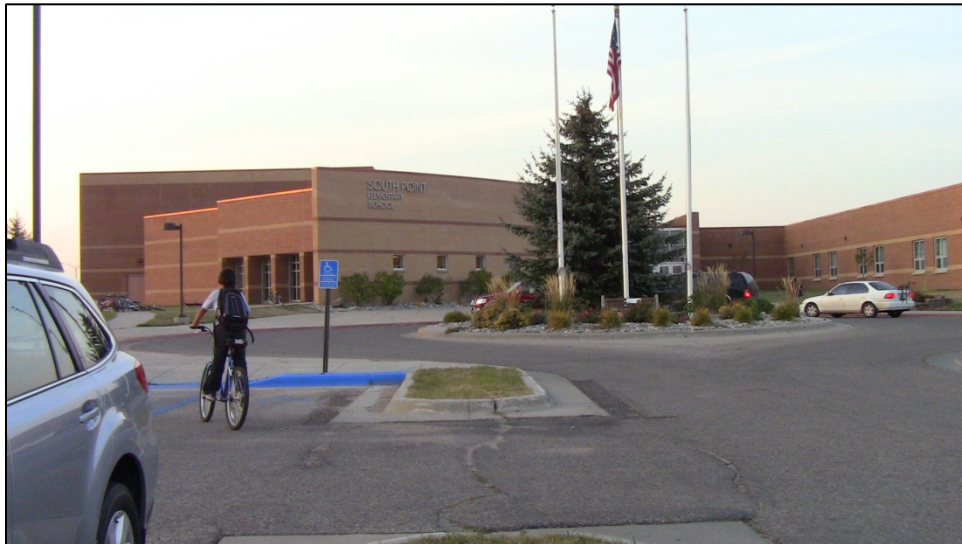
Figure 4.52 Student then riding their bike across the driveway and parking lot accessible spaces

In many cases it was observed that the kids were riding bikes that were too big for them. They were not seated comfortably and once seated their feet could not touch the ground. They struggled to pedal and also had to dismount the bike to reach the ground once stopped as seen in figures 4.52 and 4.53.

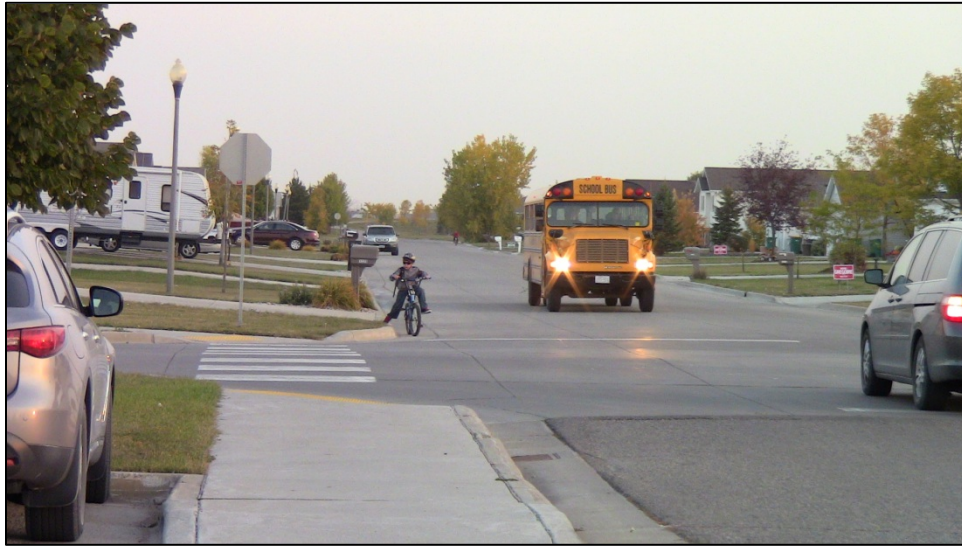
Figure 4.53 Student struggling to stay seated while stopped

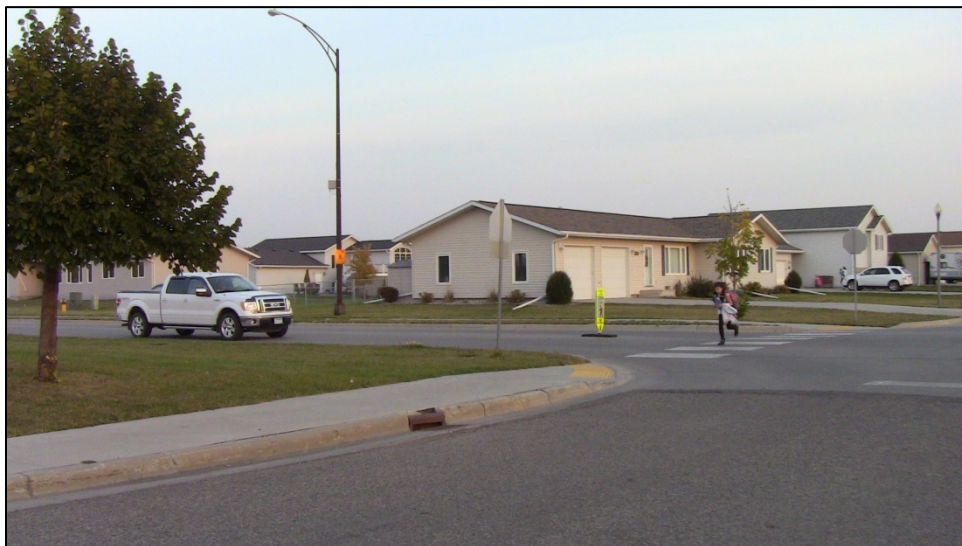
Figure 4.56 Another students running across the street without waiting for the vehicle to stop

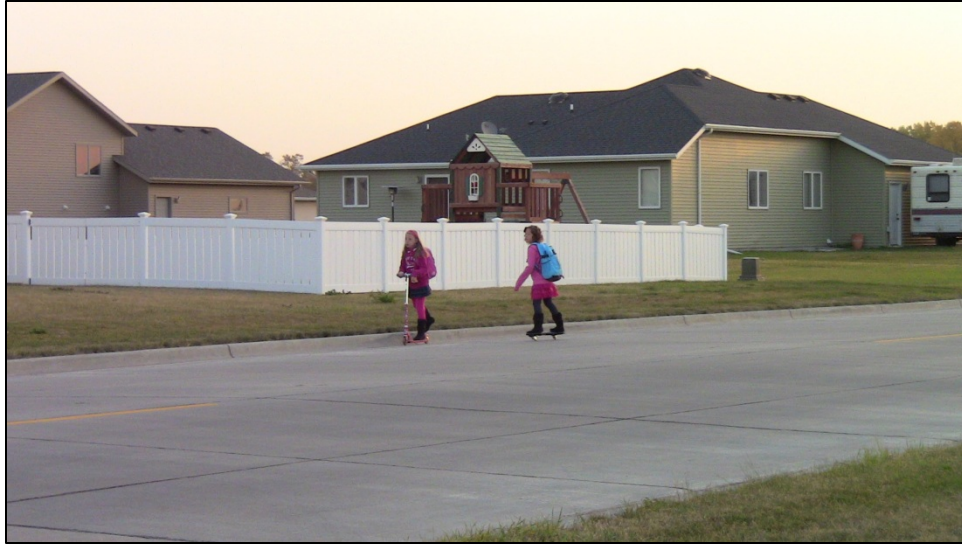
Some students were observed arriving at the school on scooters and skateboards which are known to be not street legal (figures 4.57 and 4.58).

Figure 4.57 Students riding their respective scooter and skateboard to school

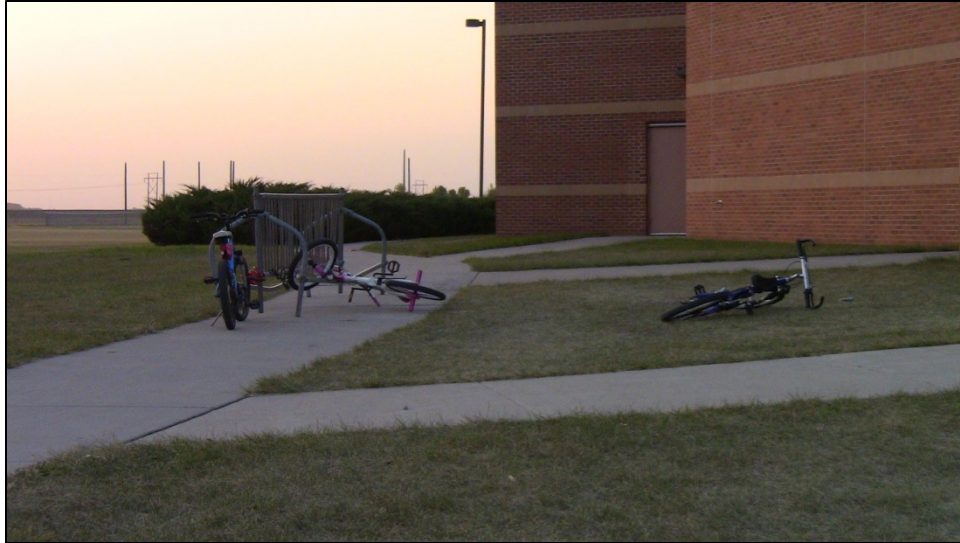
Figure 4.61 Bikes left improperly parked or even on the ground

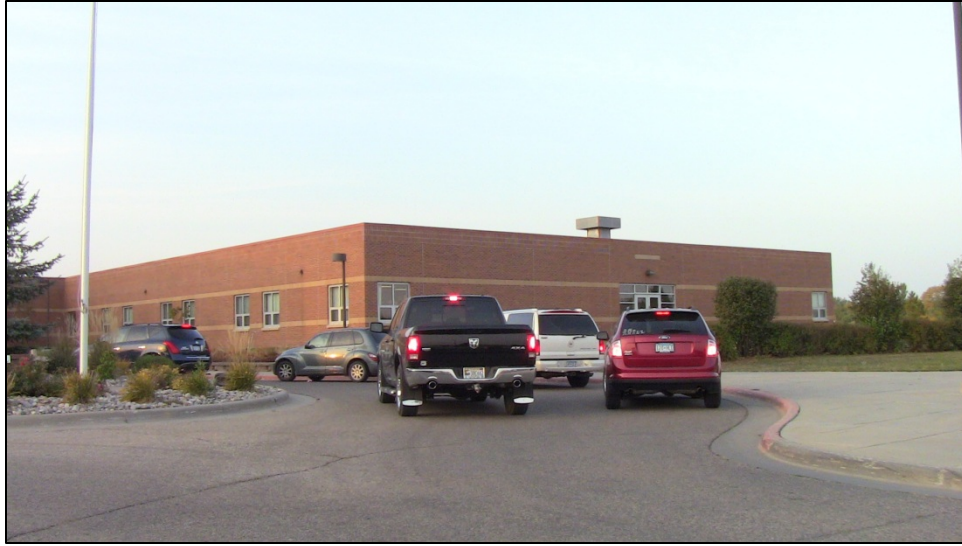
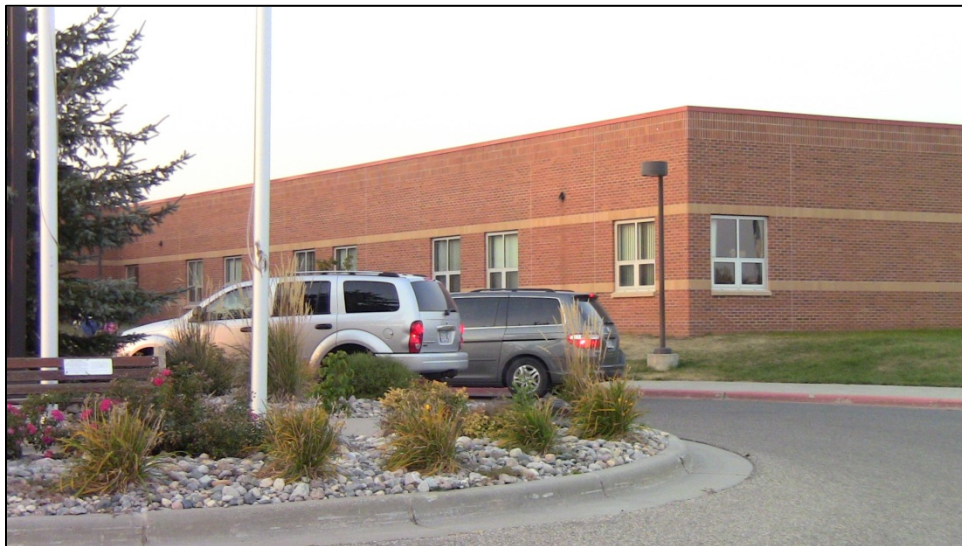
During the process of parents dropping their kids, double parking was observed numerous times as can be seen in figures 4.63 and 4.64. This not only blocked the fire lane but also made the kids walk between stopped cars. On a related note, it can also be seen that the fire lane curb marking needs to be repainted.

Figure 4.63 Parents double parking their vehicles while dropping their kids off

Figure 4.64 More vehicles double parked in the circle

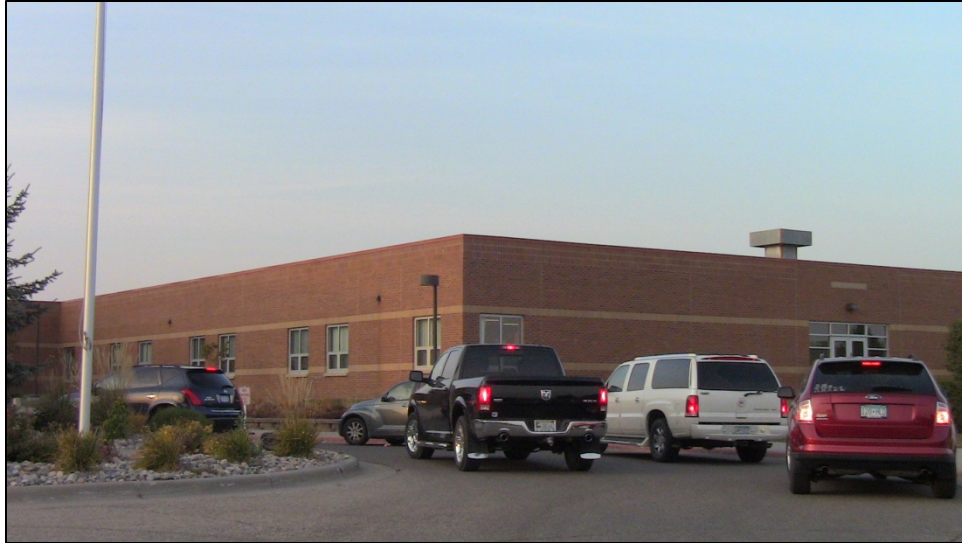
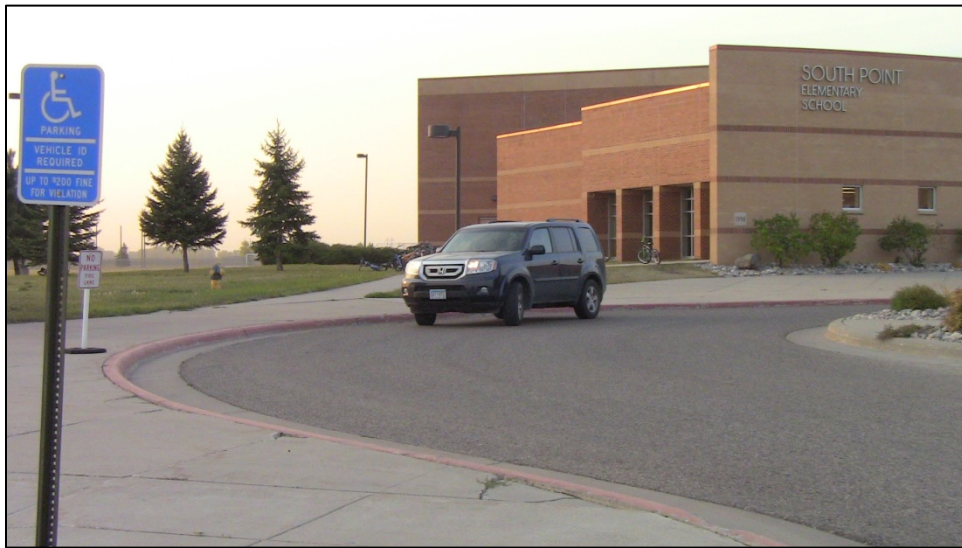
Inefficient use of the circle was also observed as the right west half was used much more than the east half as seen in figures 4.65 and 4.66 below.

Figure 4.65 Vehicles on the west half of the circle

Figure 4.66 Only one vehicle seen on the east half of the circle (picture taken a split second after the one above)

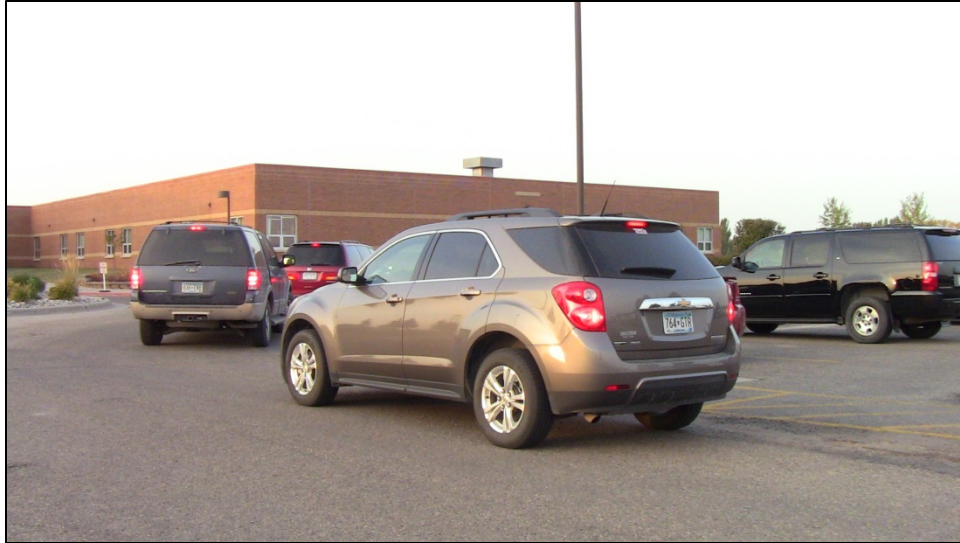
The spillback from the vehicles parked in the circle was often observed blocking the driveway as can be seen in figure 4.67 below.

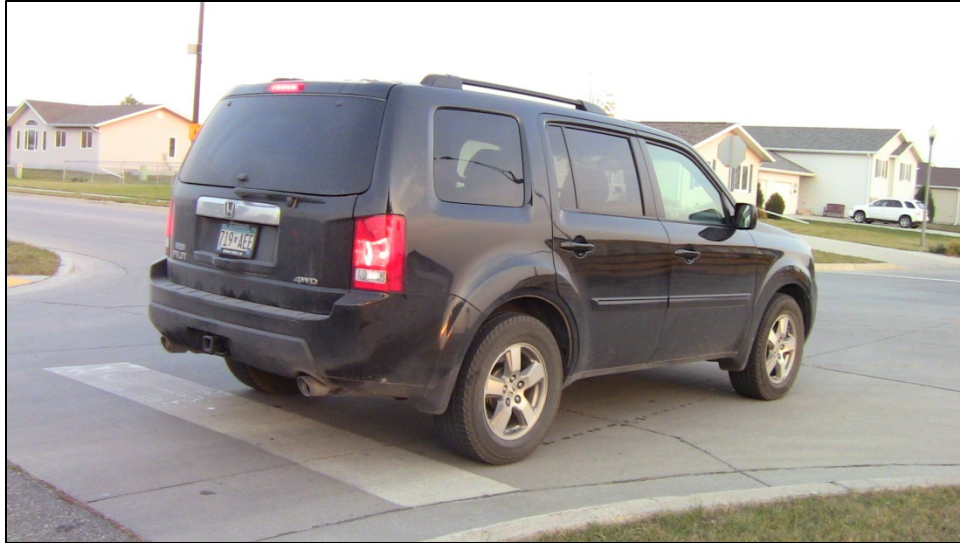
Figure 4.69 Vehicle overstepping the stop bar

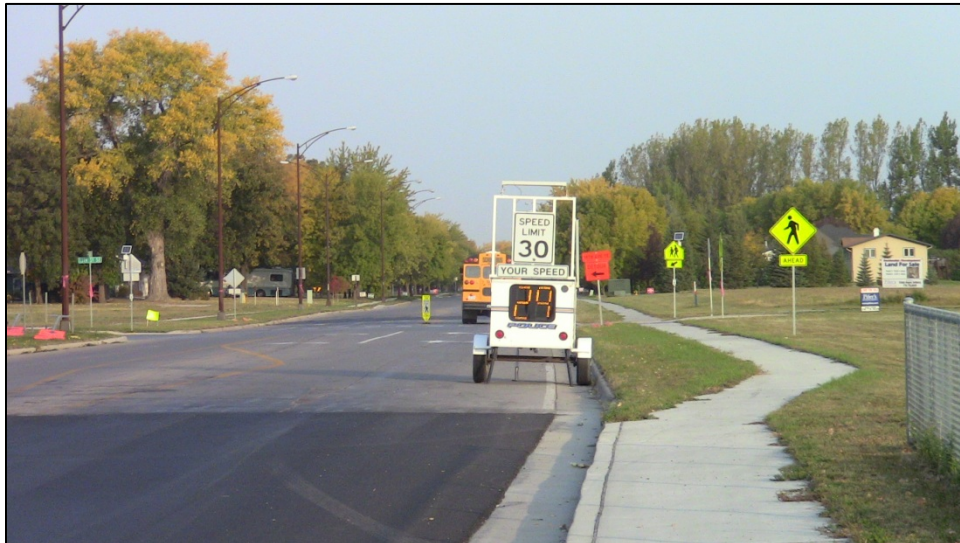
At the intersection of Bygland Rd SE and 13th St SE, a dynamic speed display sign was observed as seen in figure 4.70 below. The sign was blocking part of the traveled way of north-west-bound thru lane.

Figure 4.70 Dynamic speed display sign placed inside the traveled way
