School Safety Study for Phoenix Elementary, Lake Agassiz Elementary, and South Middle Schools

Final Report

June 2008

**Grand Forks-East Grand Forks
Metropolitan Planning Organization**

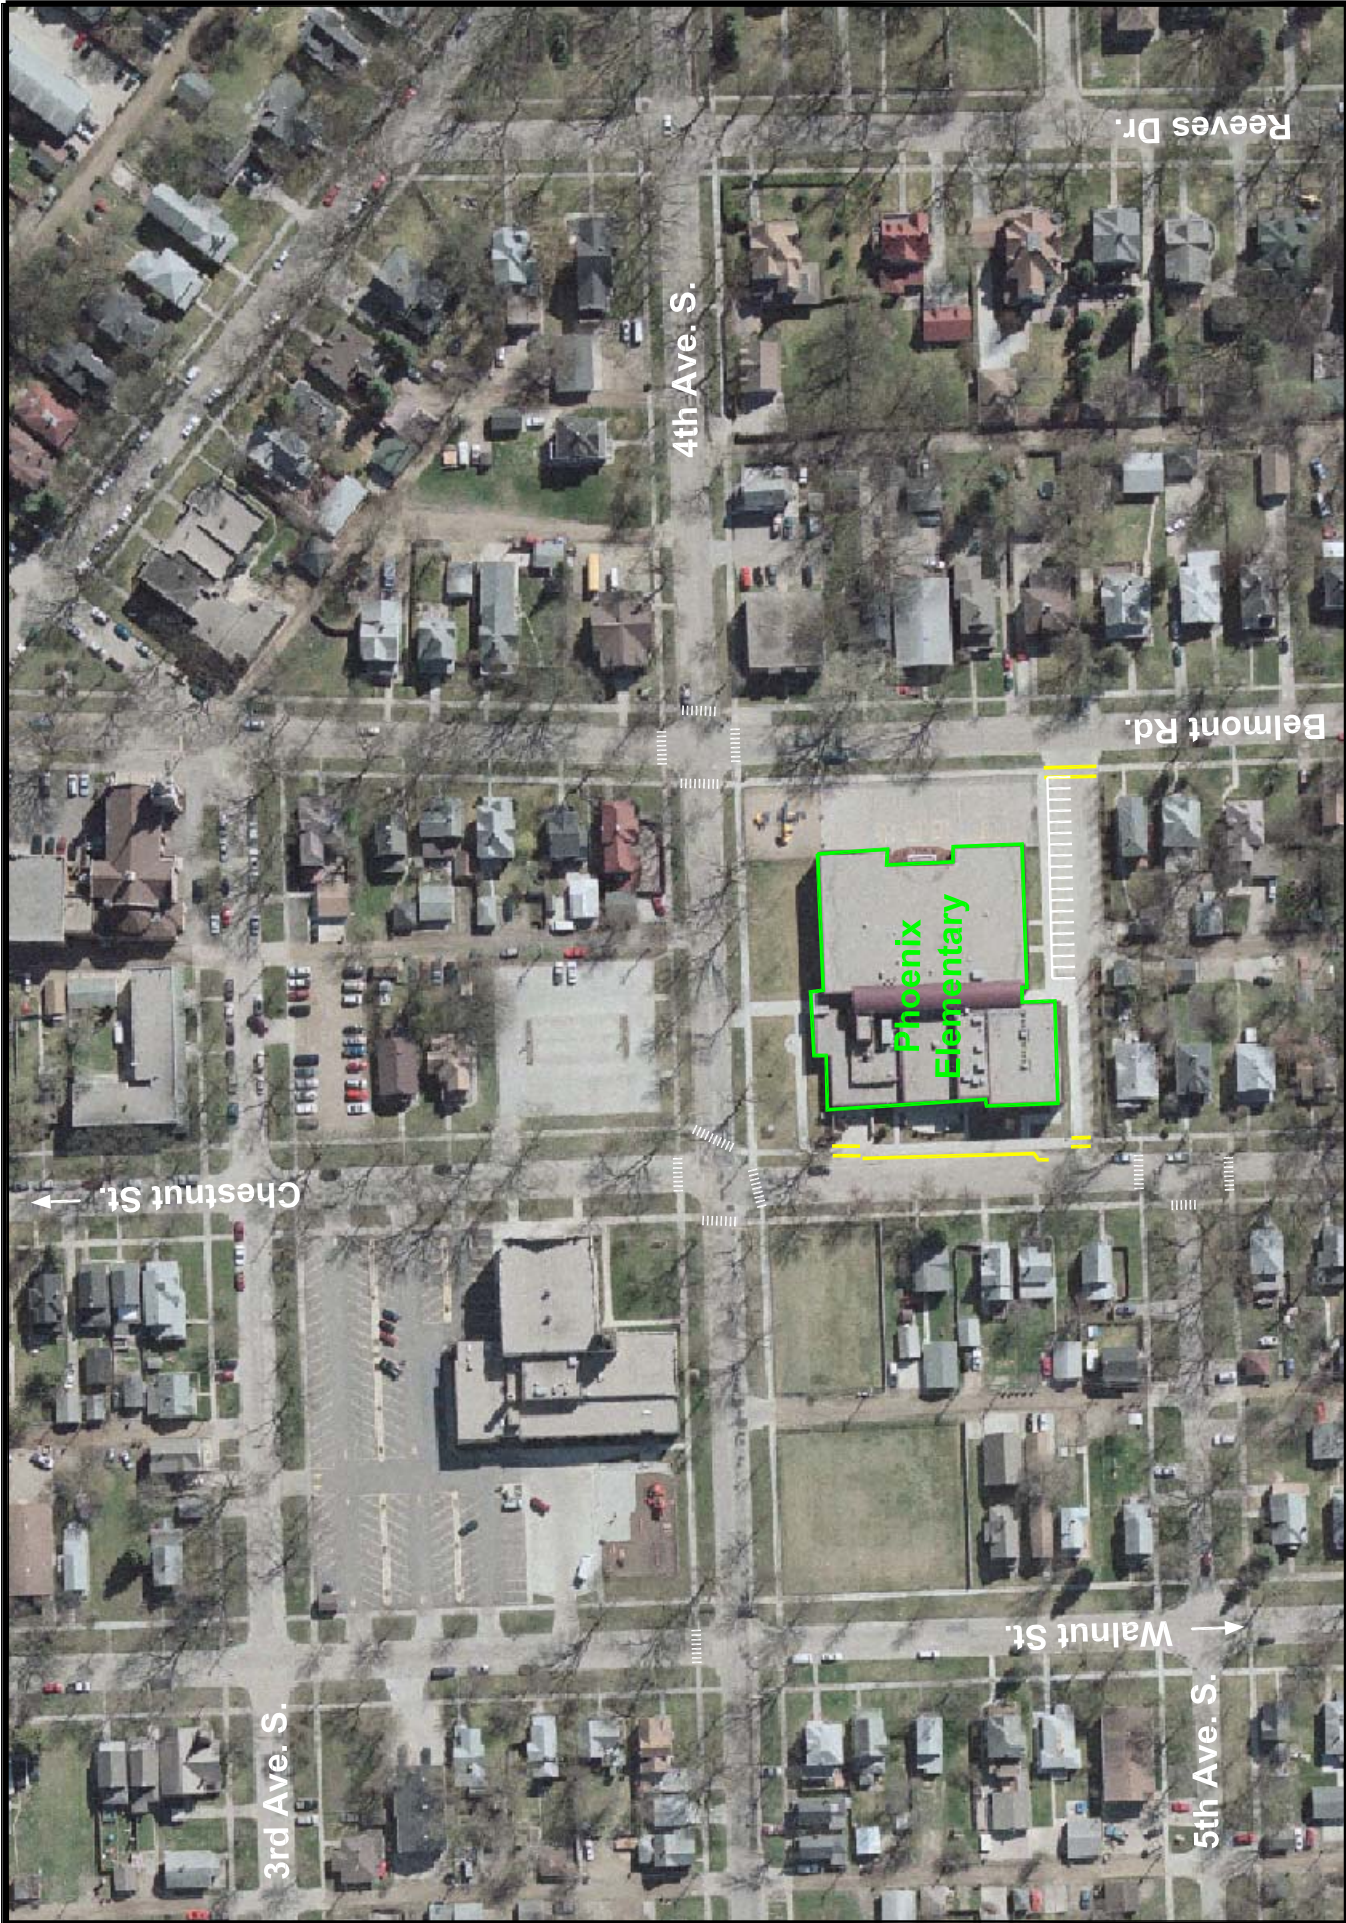
Figure 3.1

Phoenix Elementary: Existing Conditions

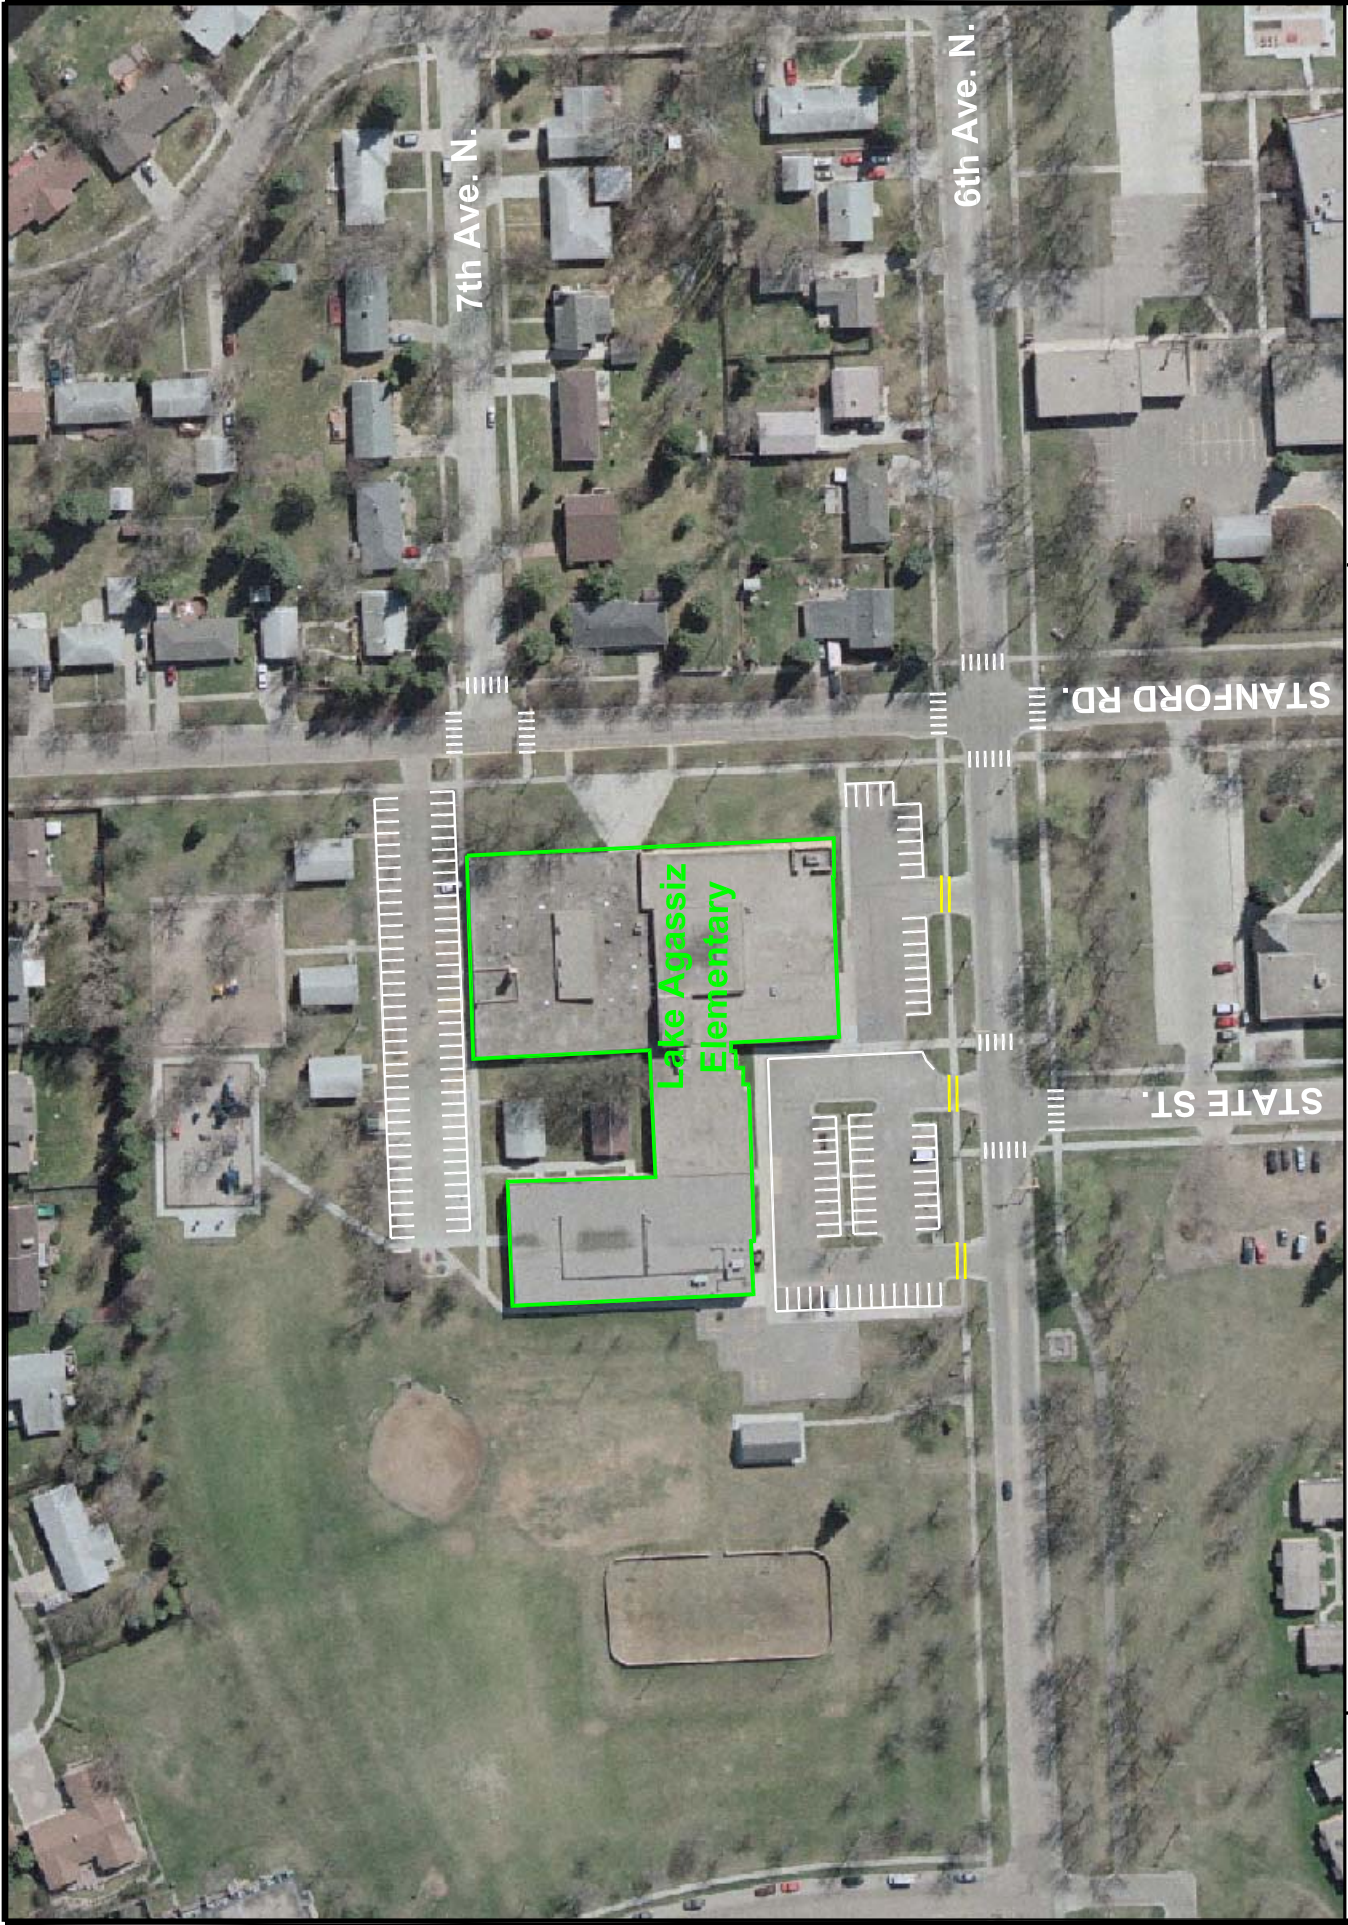
Figure 3.3

Lake Agassiz Elementary School is located in the northwest quadrant of the intersection of 6th Ave. N. and Stanford Rd. (Figure 3.3). Approximately 350 students are enrolled in grades 1-5 and approximately 80 faculty/staff are employed at the school. The school is bordered to the west and the north by a park/playground facility. There are two other roadways providing access to the school, which are 7th Ave. N. to the east, and State St. to the south.

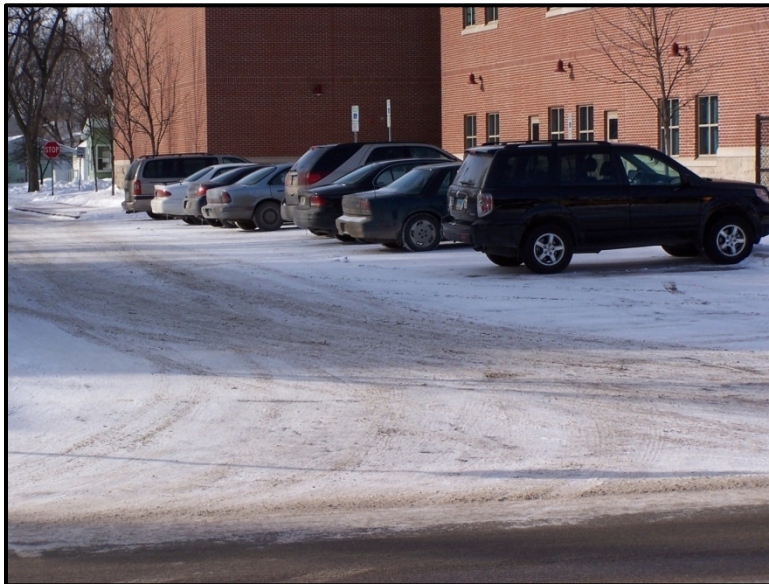
Since students are dismissed primarily to the east of the school (into the playground), parents were observed parking on the west side of Belmont Rd., and in the south parking lot. The parking lot was full approximately 15 minutes prior to dismissal, with vehicles also parking on the south side of the lot (Figure 4.1). In addition, several vehicles were parked on Belmont Rd. adjacent to the school grounds on either side of the parking lot driveway (Figure 4.2).

Figure 4.1. South Parking Lot Prior to Dismissal

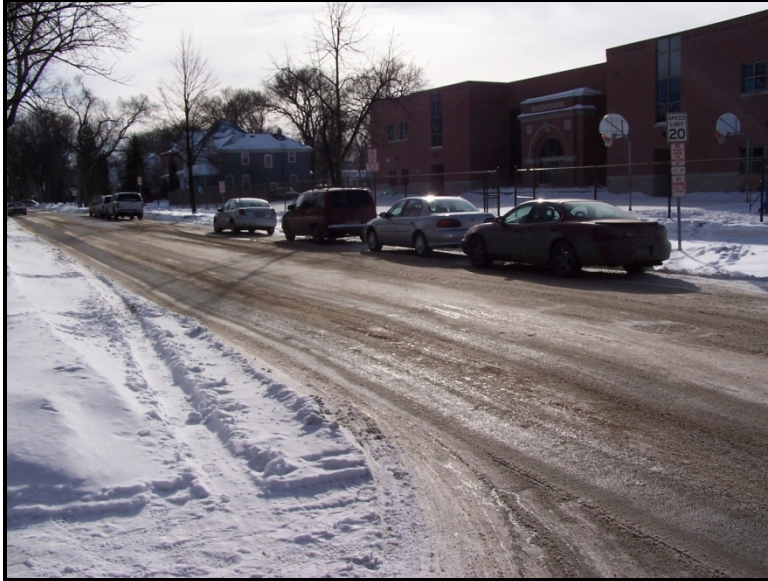
Figure 4.2. Parking on Belmont Rd. Prior to Dismissal

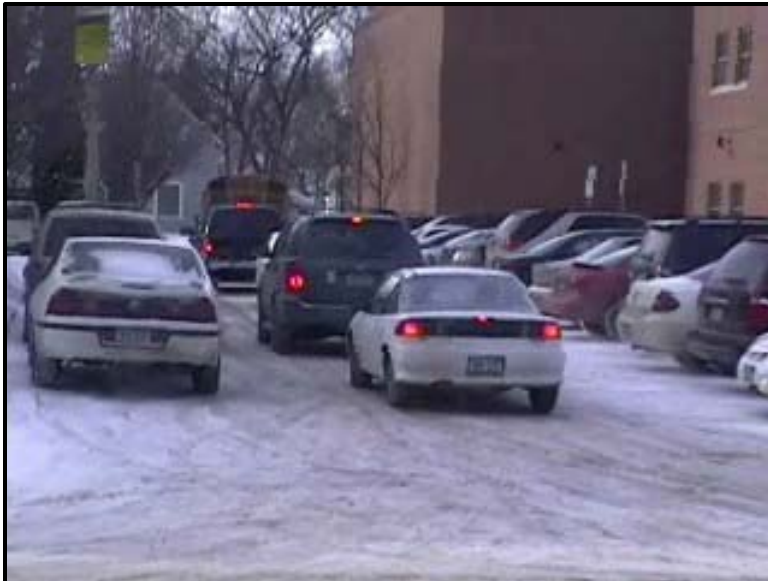
Traffic flow through the south parking lot was impeded due to the number of vehicles parked, and the congestion at the west end of the parking lot which narrows to only one exiting lane (Figures 4.3 – 4.5). A school staff member monitored the parking lot driveway/sidewalk area, which was extremely beneficial in providing a level of safety for the students crossing the driveway.

Figure 4.3. South Parking Lot During Dismissal

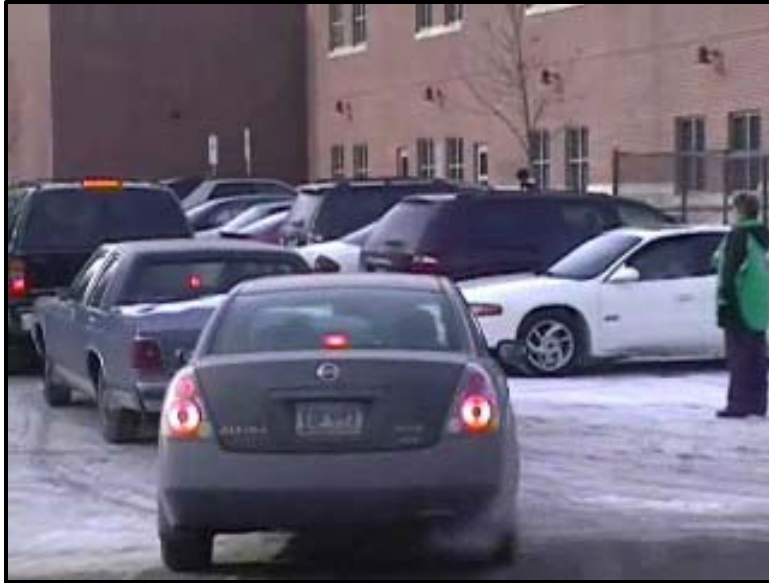
Figure 4.4. Vehicles Entering the South Parking Lot

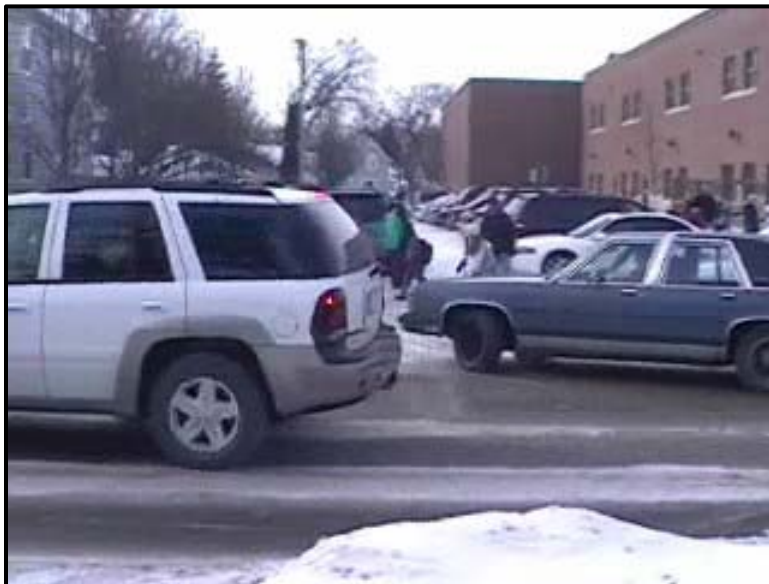
Figure 4.5. Vehicles Entering the South Parking Lot

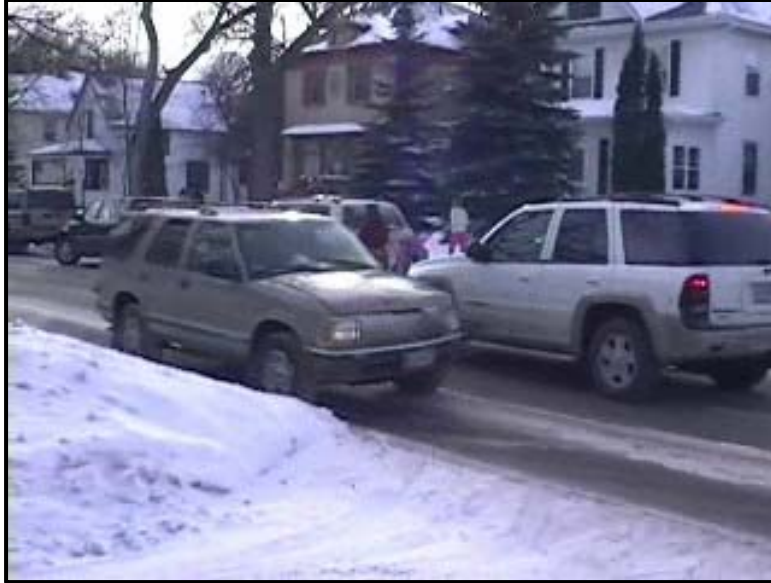
In addition to the congestion observed in the south parking lot, the vehicles parked along Belmont Rd. created a potential safety issue with passing vehicles. Parents parking on the side of the road impeded traffic when walking back to their vehicles after picking up their children, as illustrated in Figures 4.6 and 4.7. Traffic speeds, particularly on Belmont Rd., appeared to be much slower than the posted speed limit due to the vehicles parked on the west side of the road and entering the parking lot.

Figure 4.6. Pedestrian Traffic on Belmont Rd.

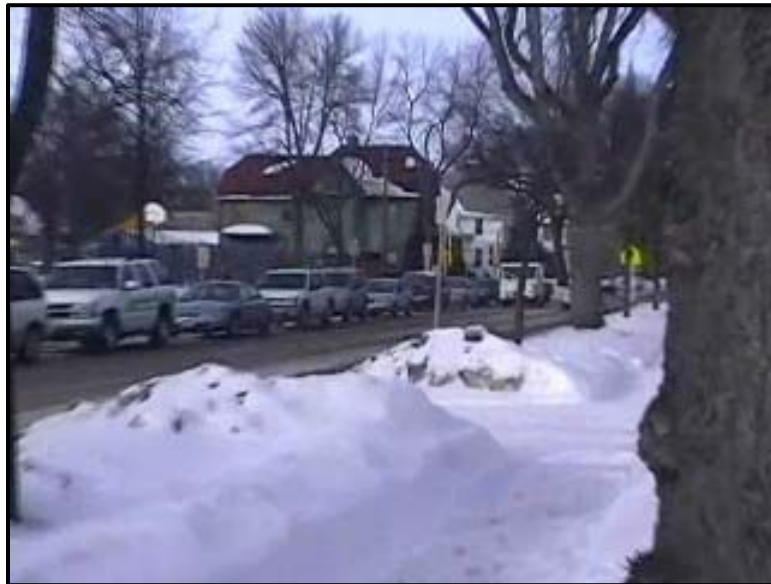
Figure 4.7. Vehicles Parked on Belmont Rd.

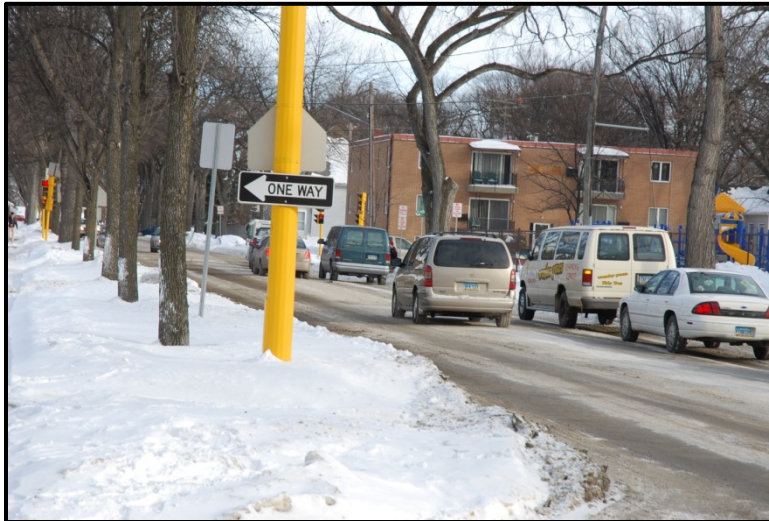
Several vehicles were parked on the west side of the school in the turnout area of Chestnut St. There were no observed issues with parking at this location; however, all of the vehicles exiting the parking lot were channeled to the north due to the one-way designation of Chestnut St. No students were dismissed from the north side of the school; however, two vehicles were observed parking along the south side of 4th Ave. S. One of the vehicles was a handicapped bus, and the other was a preschool/head-start bus. Both of these vehicles impeded vehicles traveling eastbound, which also had an impact on westbound vehicles (Figure 4.8).

Figure 4.8. Parking on 4th Ave. S.

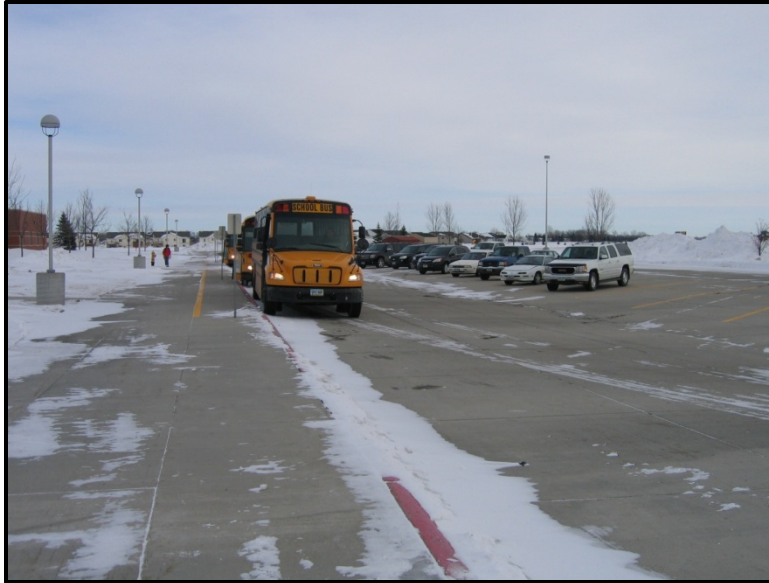
The dismissal process on the south side of the school was efficient, and no obvious issues were observed. Parents parked in the parking spaces facing the school while waiting to pick up students. Once students were picked up, the vehicles departed using the south entrance to 20th St. The south parking lot was approximately half full during dismissal, and no issues were observed with either vehicle parking or movement through the parking lot (Figure 4.9).

Figure 4.9. Vehicles Parked in the South Parking Lot

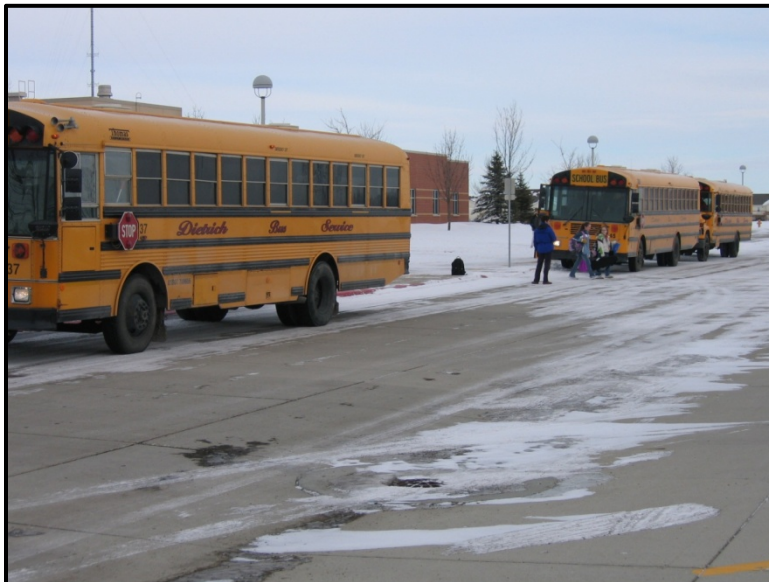
The north side of the south parking lot also serves as a bus loading zone. A total of five large busses parked along the north curb where students were loaded. Due to its location, the crosswalk that enters the parking lot was located between two busses. Two staff members were present at the south side of the school, to direct students to their designated bus and monitor the students using the crosswalk into the parking lot (Figure 4.10).

Figure 4.10. Pedestrian Crossing in the South Parking Lot

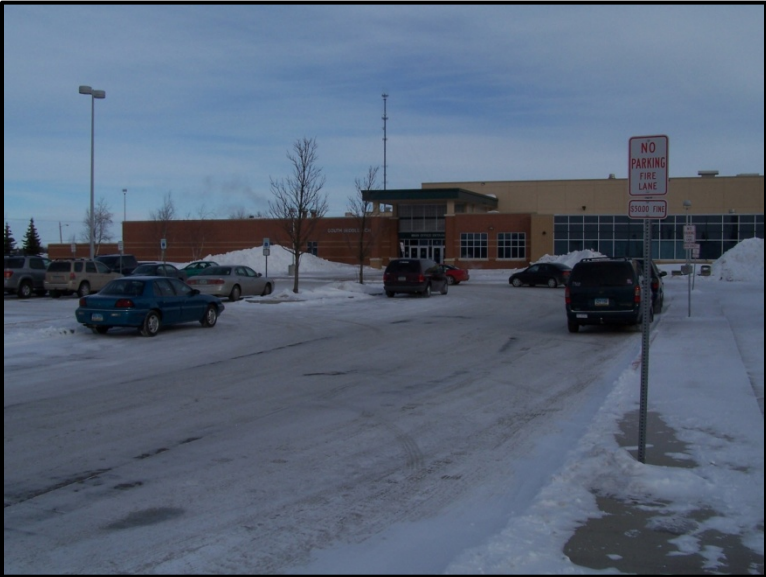
The operational characteristics of the north parking lot were also observed. This lot was found to be somewhat deficient in comparison to the south parking lot. Parents were observed parking in the loading zone/fire lane along the near-side curb (Figure 4.11), and on the north edge of the north parking lot (Figure 4.12) approximately 15 minutes before school was dismissed.

Figure 4.11. Parking Prior to Dismissal in the North Parking Lot

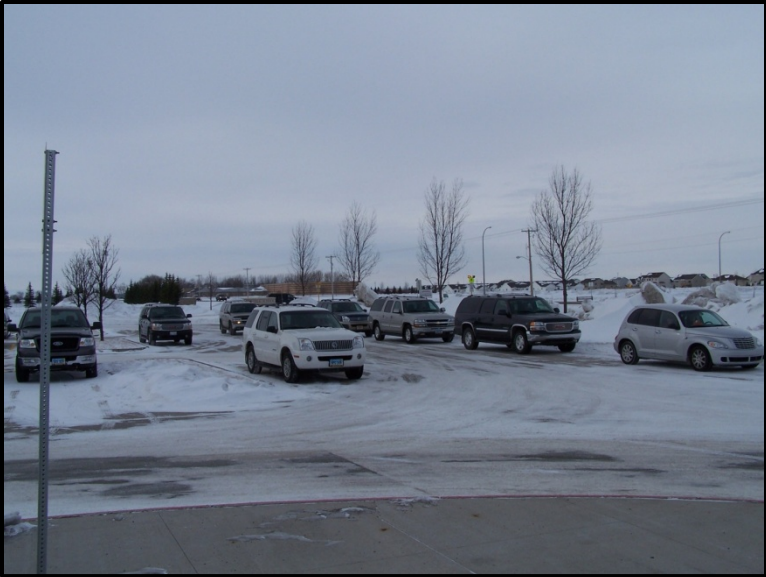
Figure 4.12. Parking on the North Side of the North Parking Lot

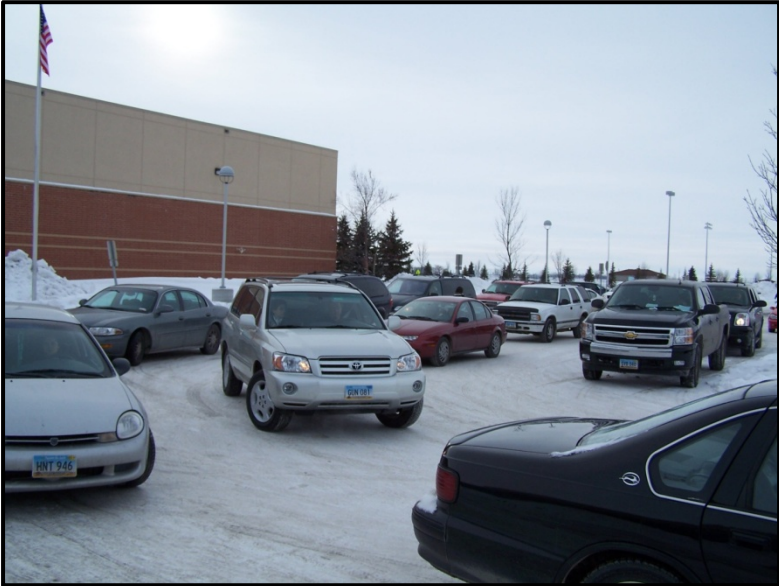
During school dismissal, vehicles were parked three-abreast in the driveway/fire lane in front of the main entrance (Figure 4.13). Other popular parking locations included both

Figure 4.13. Vehicle Parking at the Main Entrance

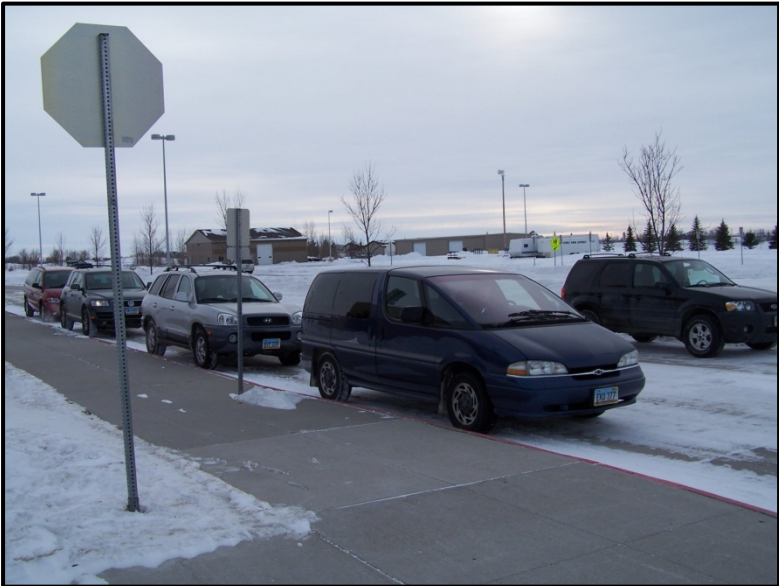
sides of the frontage road to the west (Figure 4.14), and in the aisles of the parking lot (Figure 4.15).

Figure 4.14. Vehicles Parked on the Frontage Road

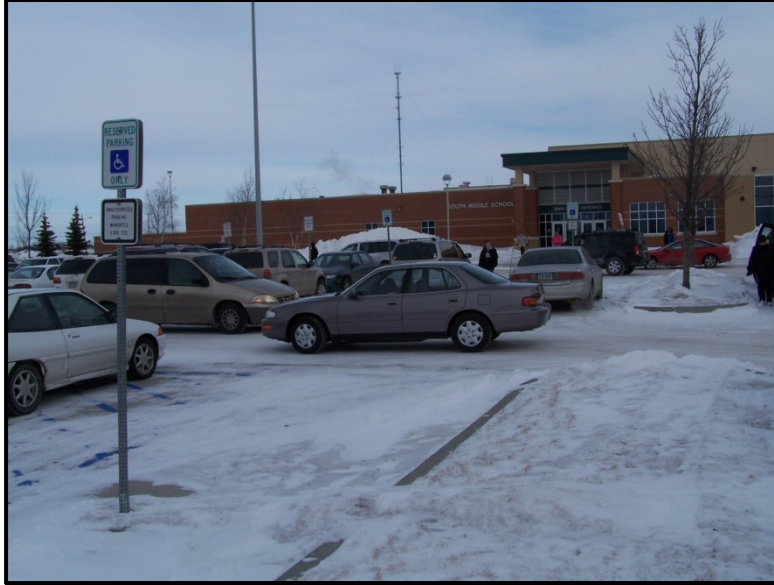
Figure 4.15. Vehicles Parking in the Parking Lot Aisles

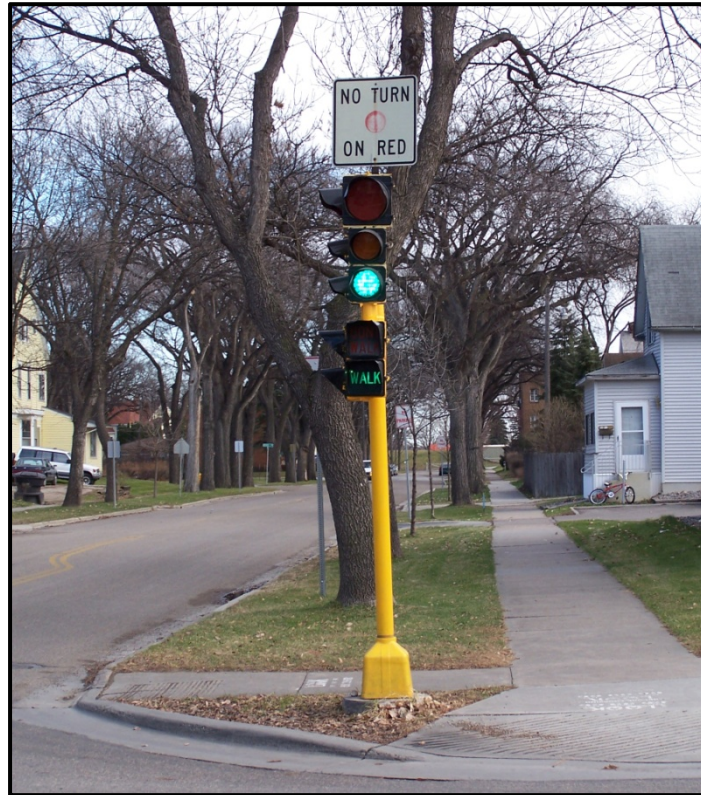
A few issues were observed at the intersection of 4th Ave. S. and Belmont Rd. The 'WALK' indication on the signal is green (Figure 5.1). According to the 2003 MUTCD, the pedestrian 'WALK' indication should be white. In addition, the 'No Turn On Red'

sign is significantly faded. Also, this type of sign is no longer used in the current edition of the MUTCD. The updated sign is shown in Figure 5.2.

Figure 5.1. Green 'WALK' Indication/Faded Sign at 4th Ave. S. and Belmont Rd.

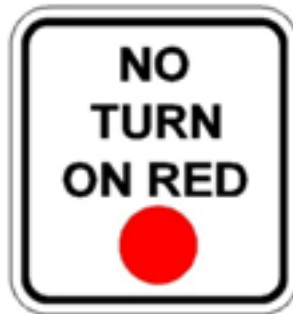
Figure 5.2. Sign Change Recommendation at 4th Ave. S. and Belmont Rd.

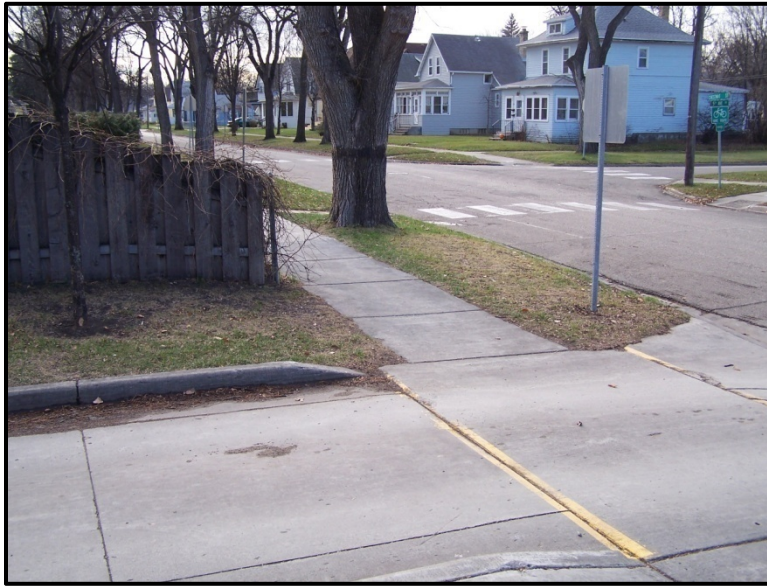
A site obstruction was observed at the exit of the south parking lot when turning on to Chestnut St. (Figure 5.3). There is a fence and shrub on the property to the south of the driveway which extends to the sidewalk. This obstructs the view of oncoming vehicles and pedestrians, and vehicles exiting the parking lot need to pull onto the crosswalk to see oncoming traffic. A short-term improvement would be to remove or lower the fence/bush to improve the sight distance at this intersection.

Figure 5.3. Sight Obstruction at the West Exit of the South Parking Lot

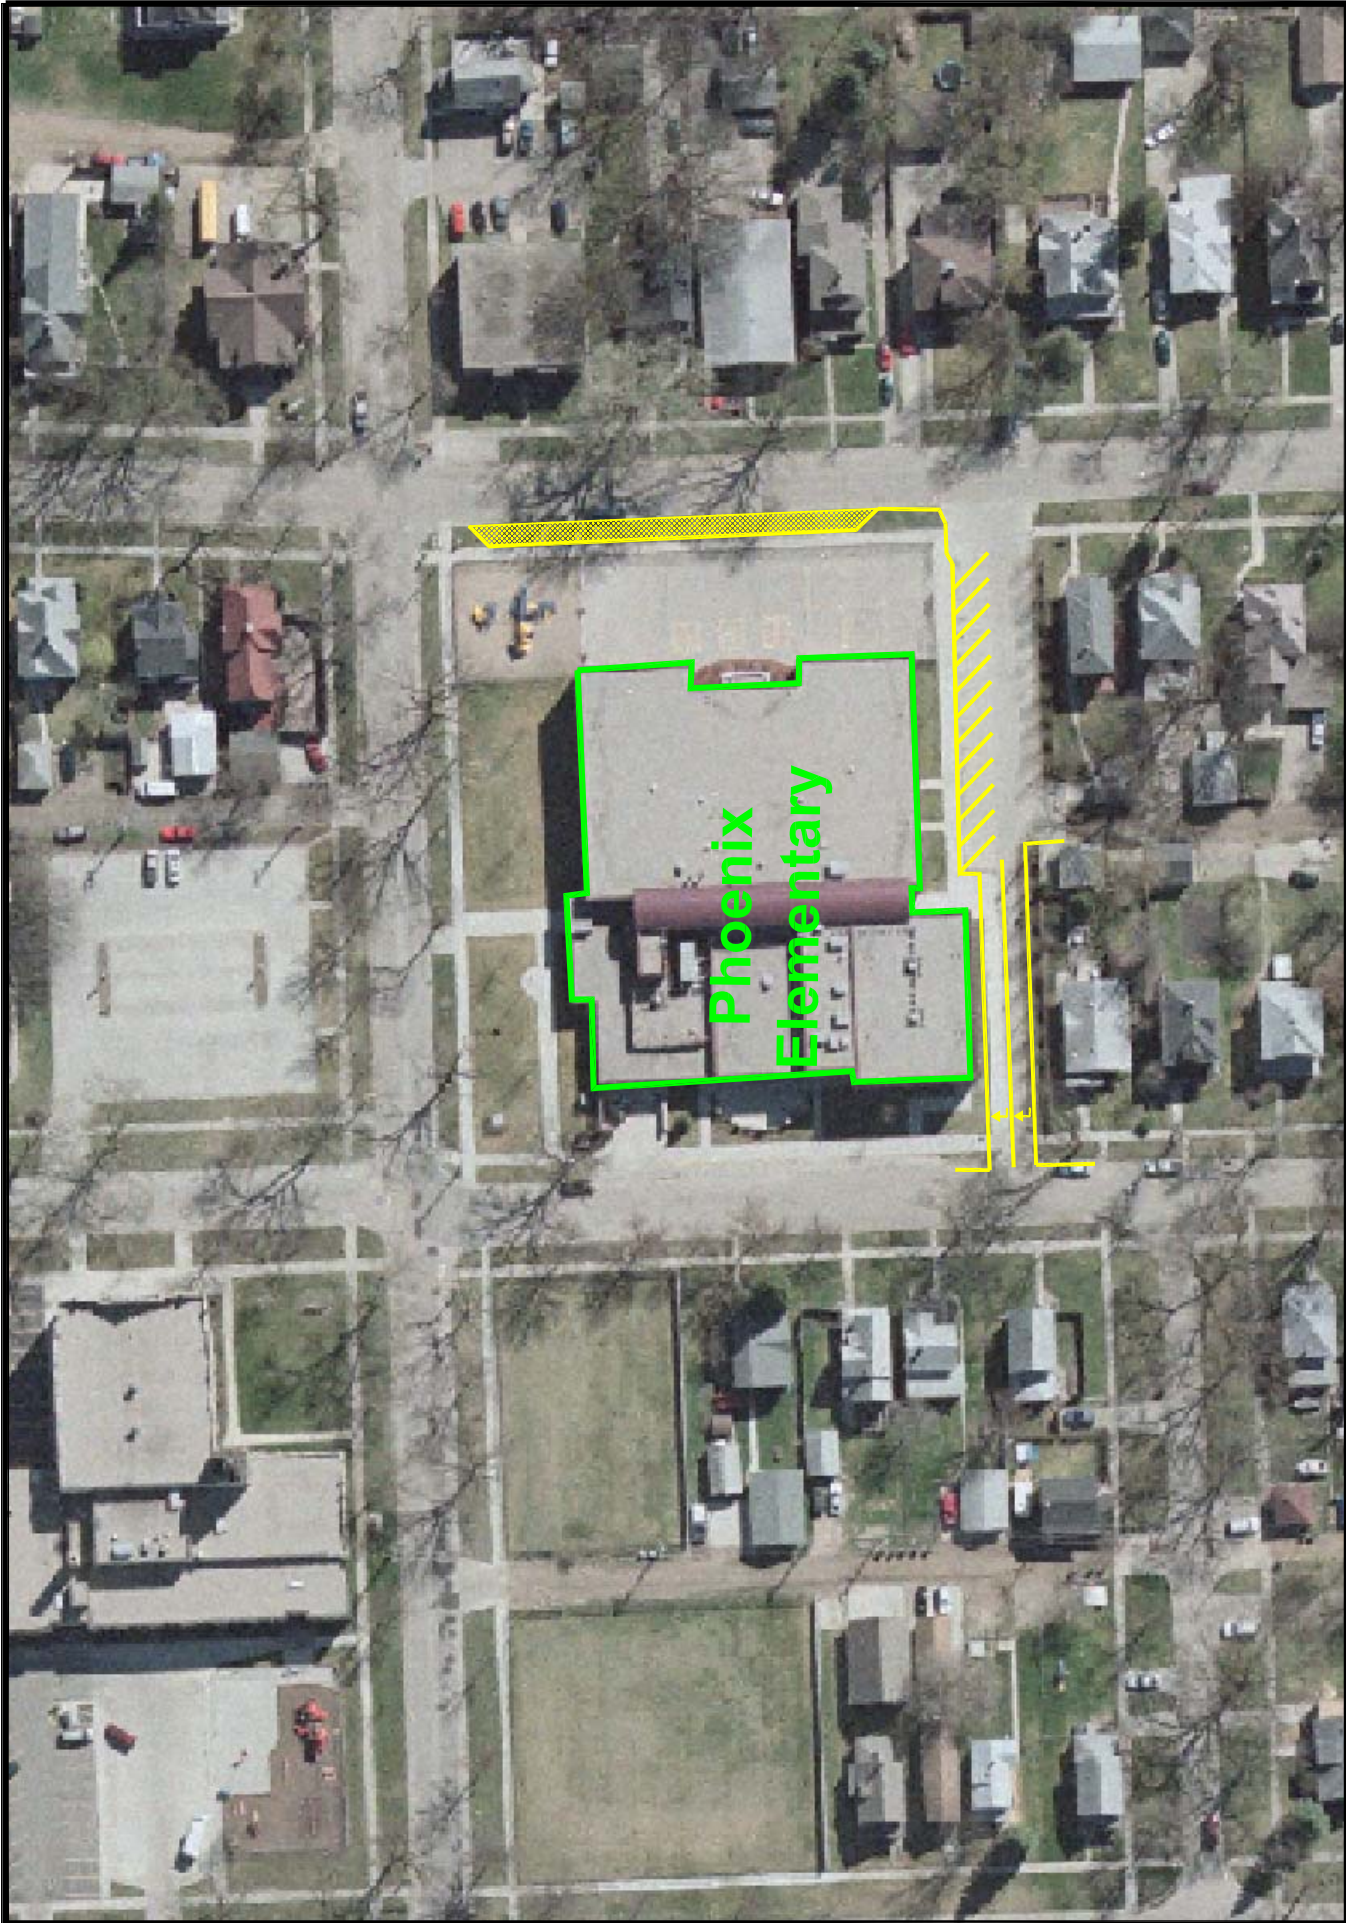
Figure 5.5

Due to its location, the options for making geometric changes at the school are relatively limited. Three proposed changes were developed to help improve the operational characteristics at Phoenix Elementary School (Figure 5.5). The first change would be to add a turn-out lane on the west side of Belmont Rd. (adjacent to the school). This would provide a safer parking option for parents during the dismissal period, and help to reduce blockage of passing vehicles. The second proposed change adjusts the angle of the parking in the south parking lot from 90° to 60°. This would encourage a one-way flow in the parking lot, and improve the sight of drivers when backing out. The final geometric proposal is to add an additional lane exiting the south parking lot to the west (Chestnut St.), and create a double-right-turn at the intersection. Due to the one-way operation of Chestnut St. it may be difficult for vehicles to exit the south parking lot. However, a two-way operation could improve traffic flow exiting the school. The cost estimates for the long-term strategies at Phoenix Elementary School are illustrated in the following table:

Table 5.1. Cost Estimates for Long-Term Strategies

Turn-out Lane on Belmont Rd.	
Asphalt	\$8,800
Concrete	\$13,200
Parking Lot Extension	
Asphalt	\$27,000
Concrete	\$31,400

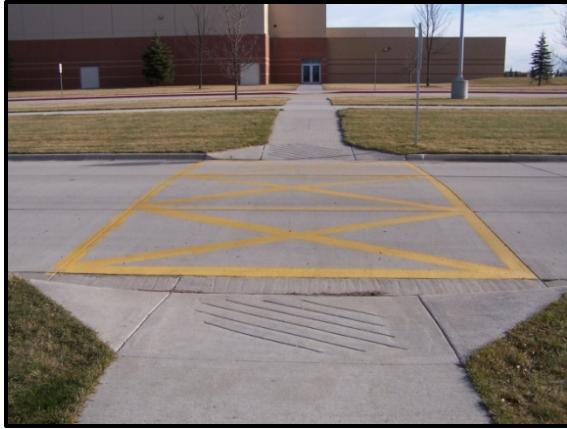
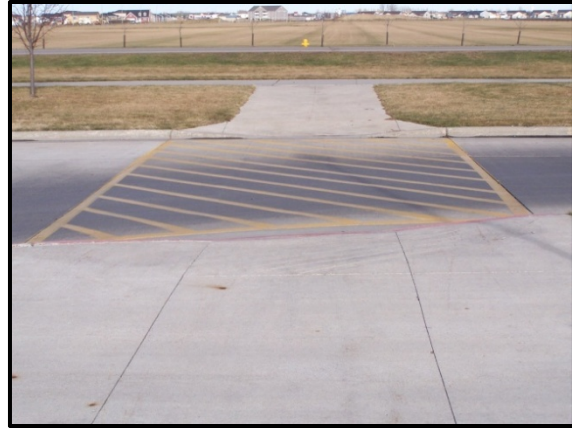
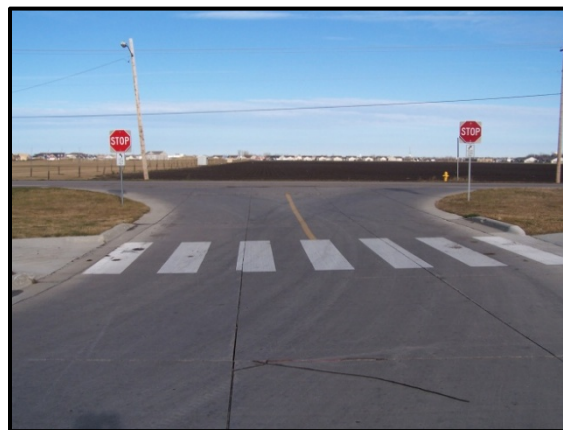
Three different types of crosswalk delineation are used at South Middle School (Figure 5.7). It is recommended that these be changed to reflect uniform markings throughout school grounds. This will also help to reduce any driver confusion in regard to the validity of the crossings.

Figure 5.7. Crosswalk Markings at South Elementary School
