School Safety Study for Schroeder Middle, Valley Middle, and South Point Elementary Schools

Final Report

February 2013

Prepared for:
Grand Forks – East Grand Forks Metropolitan
Planning Organization

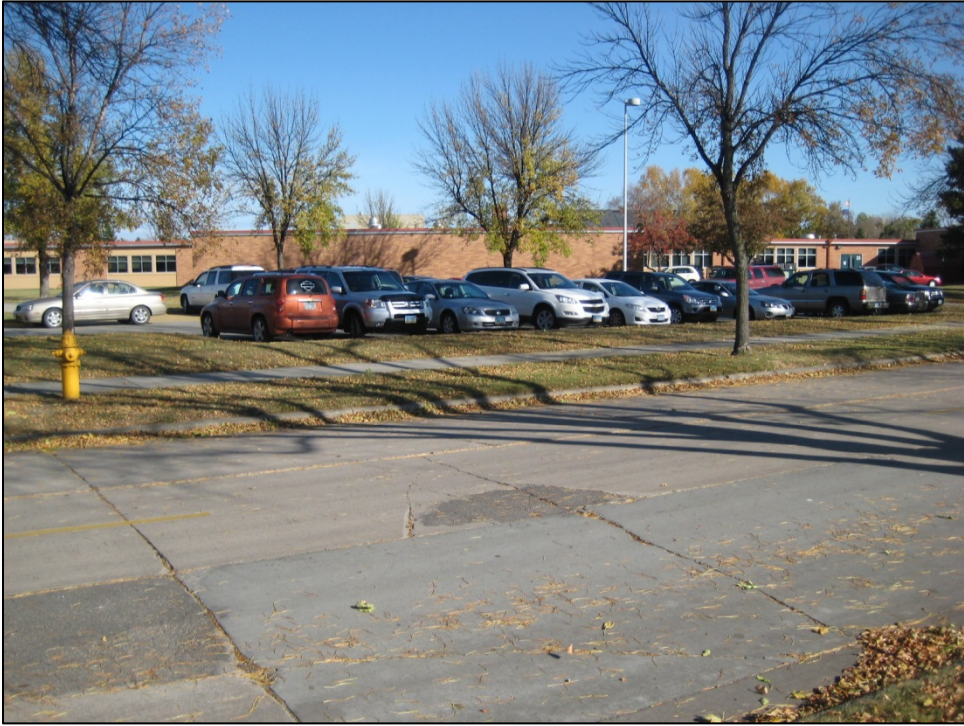
Figure 4.5 Full parking at the west parking lot

Given the fact that the west parking lot does not have a lot of spaces, it was not surprising to see it full, as shown in figure 4.5 above. However, vehicles were seen stopped/parked in the driveways and other non-designated areas of the lot as shown in figure 4.6 above.

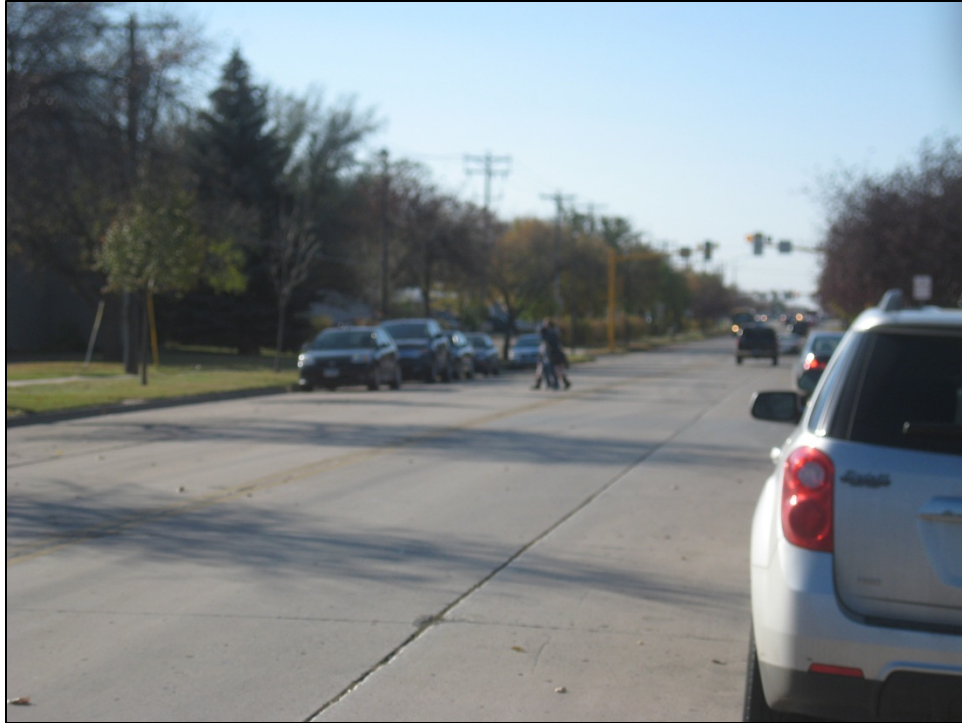
Figure 4.12 Parent walking their kids across the street on 32nd Ave S

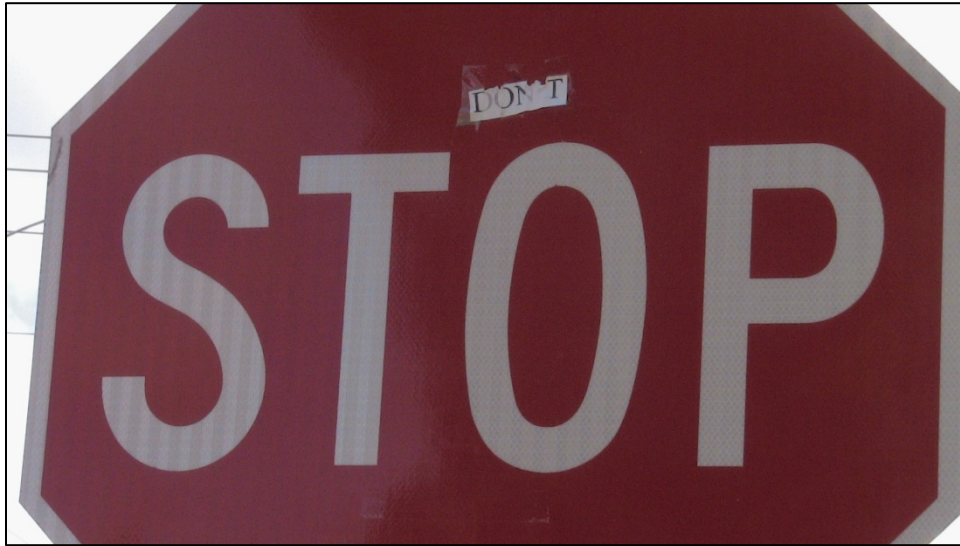
Figure 4.35 Graffiti on another stop sign

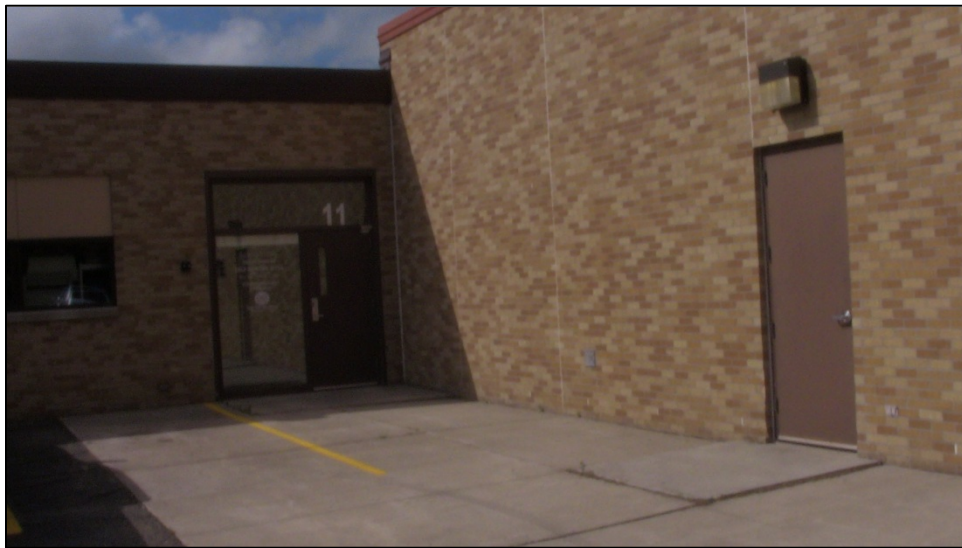
Many parking spots in the north-east parking lot were found to be blocking the doors. These were mainly accessible spaces. However, vehicles parked in those spaces would inadvertently block the exits as can be clearly seen in figures 4.37 and 4.38 below.

Figure 4.38 Another parking space potentially blocking adjoining doors

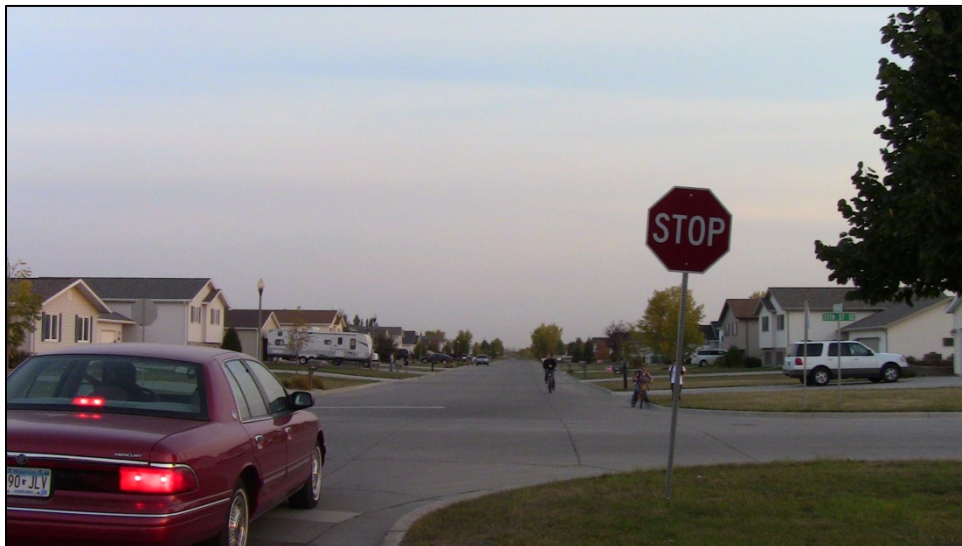
Also, students were seen riding their bikes on the wrong side of the street as seen in figures 4.48 and 4.49 below.

Figure 4.48 Students riding their bike on the wrong side of the road

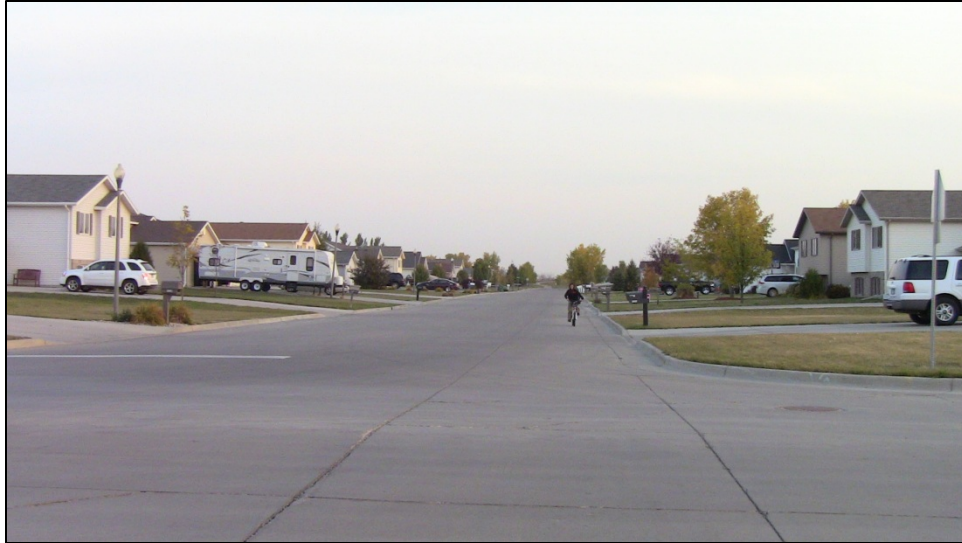
Figure 4.49 Another student riding their bike on the wrong side of the road

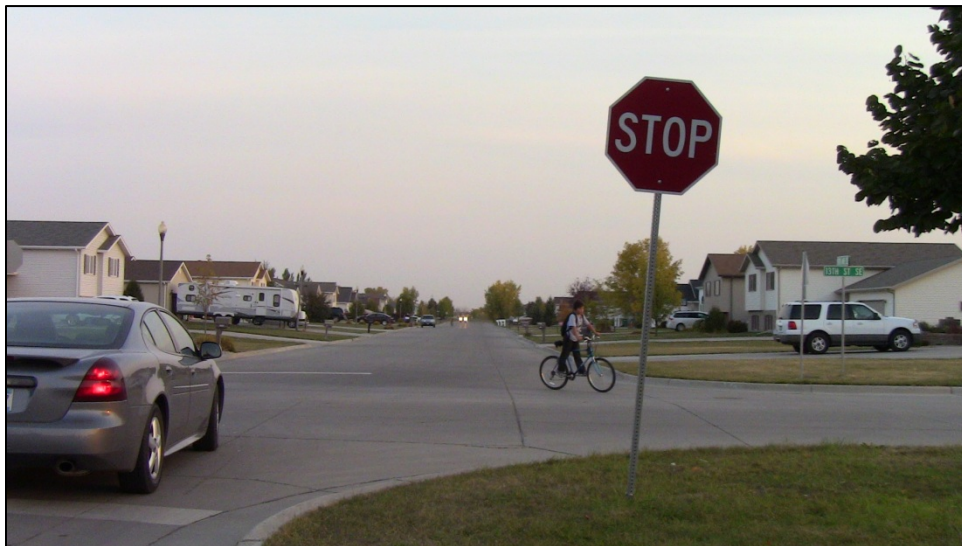
Some students were seen riding their bike in a haphazard manner as can be seen in figures 4.50 thru 4.52 below.

Figure 4.50 Student riding their bike in a haphazard manner as a vehicle is stopped in driveway

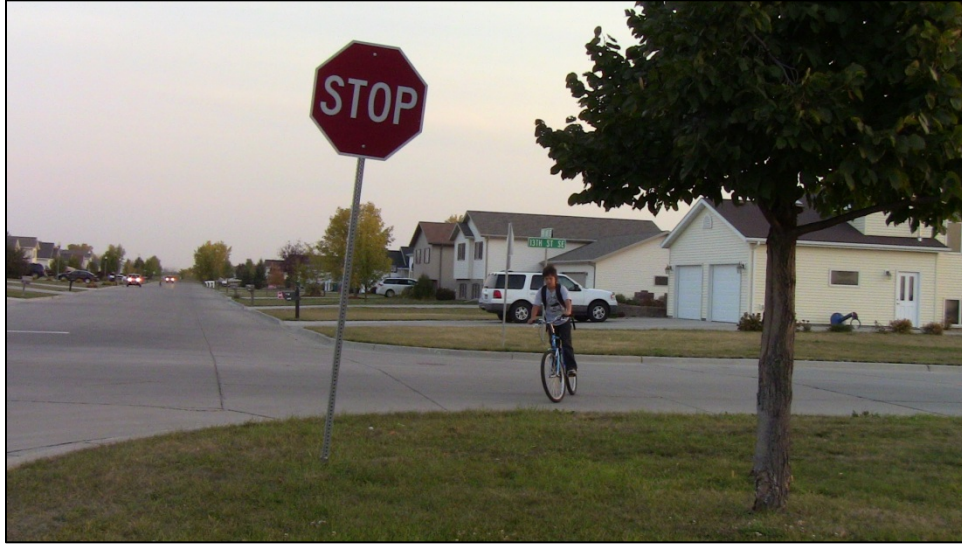
Figure 4.51 Student continuing to ride their bike in a haphazard manner

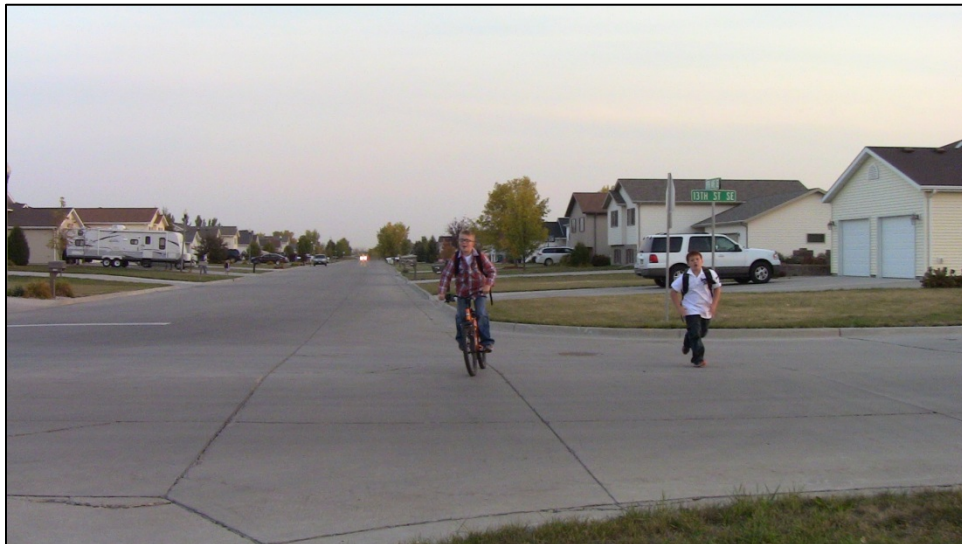
Drivers were seen obeying the signs as expected and were stopping for pedestrians in the crosswalk. However, many students were seen running across the street as can be seen in figures 4.54 thru 4.56 below.

Figure 4.54 Student running across the street while another students rides their bike on the wrong side of the roadway

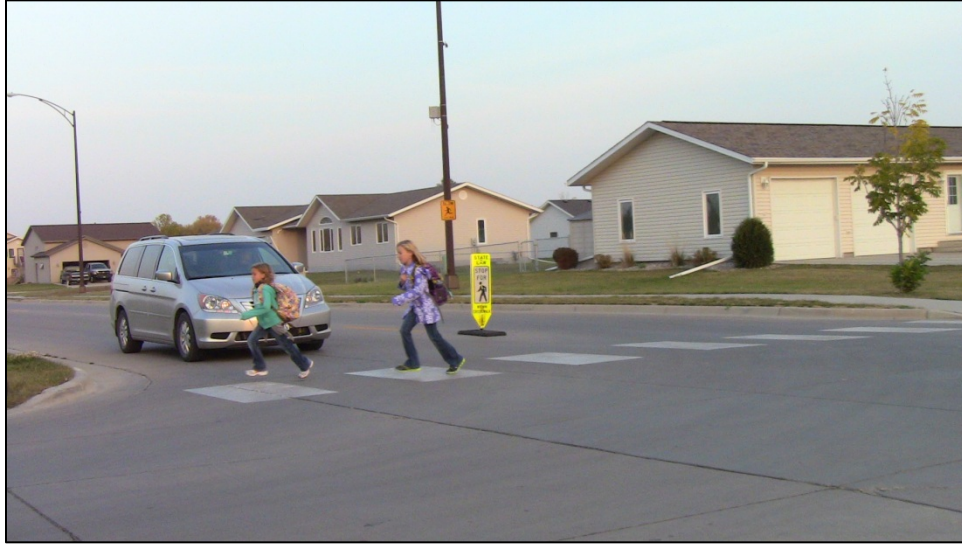
Figure 4.55 Students running across the street while a vehicle is stopped

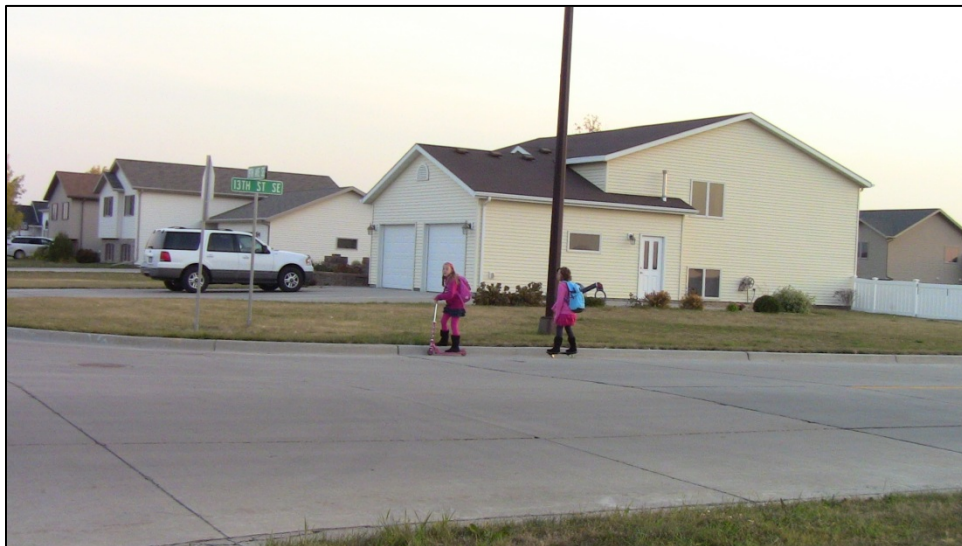
Some students were observed arriving at the school on scooters and skateboards which are known to be not street legal (figures 4.57 and 4.58).

Figure 4.58 Same students continuing to ride their respective scooter and skateboard to school

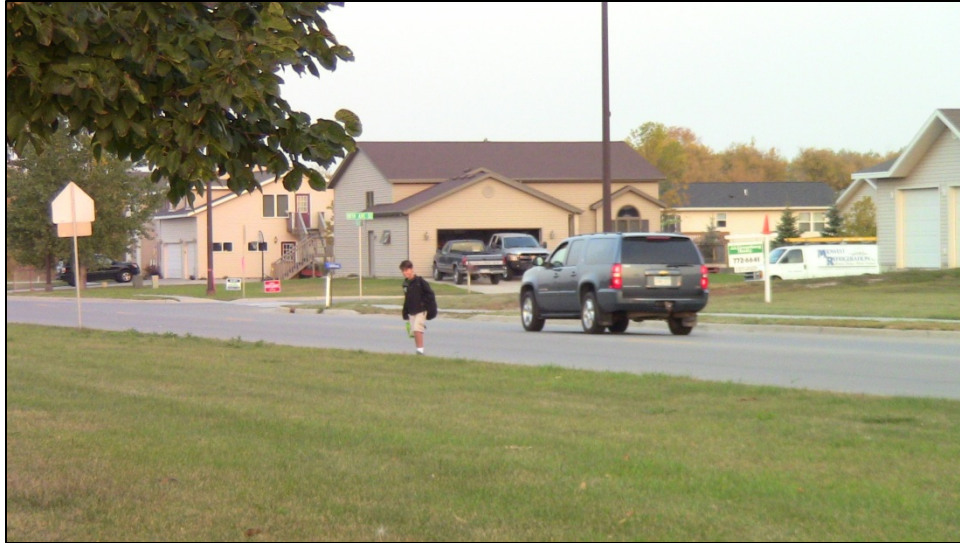
Some students were seen crossing the street midblock as can be seen in figure 4.59 below

Figure 4.59 Student crossing the street midblock

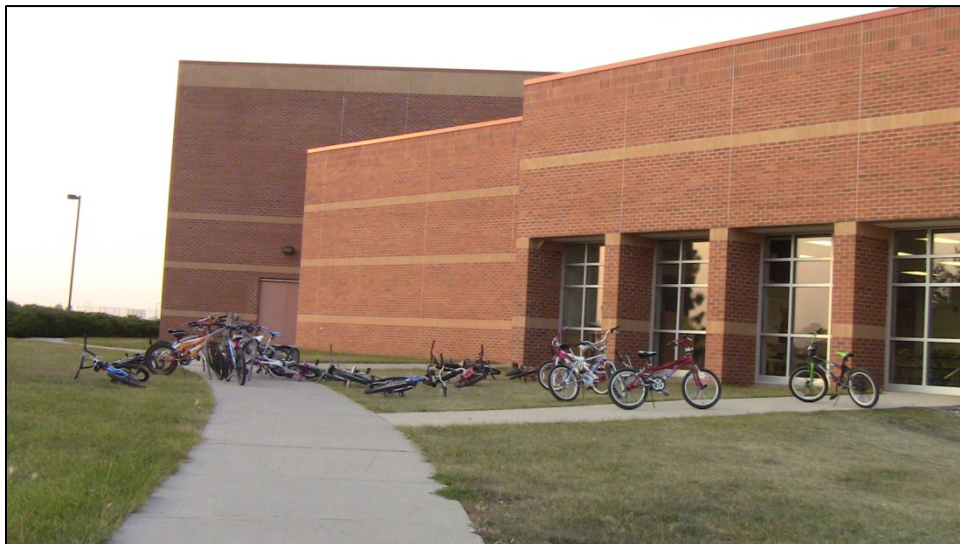
The bike rack was insufficient for the number of students who rode their bike to school and the students left their bikes lying all around the place as seen in figure 4.60 below.

Figure 4.60 Bikes left all over the place and some even on the path leading to the door

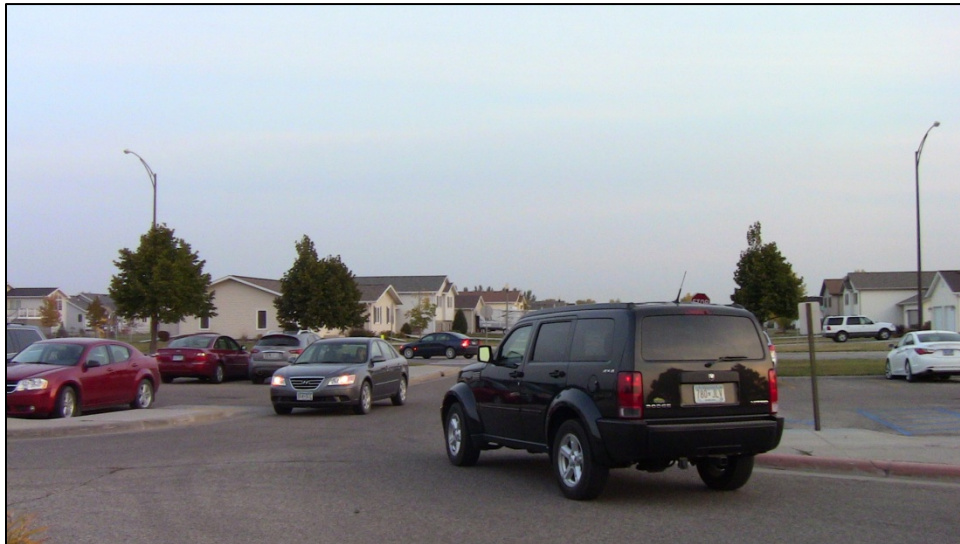
The two-way driveway leading to the circle was seen to be too narrow for two vehicles going in the opposite directions. The driveway is approx. 18' wide. One of the vehicles had to essentially stop to let the other vehicle clear the driveway as seen in figure 4.68 below.

Figure 4.68 The vehicle on the right had to stop to let the one on the left clear the driveway

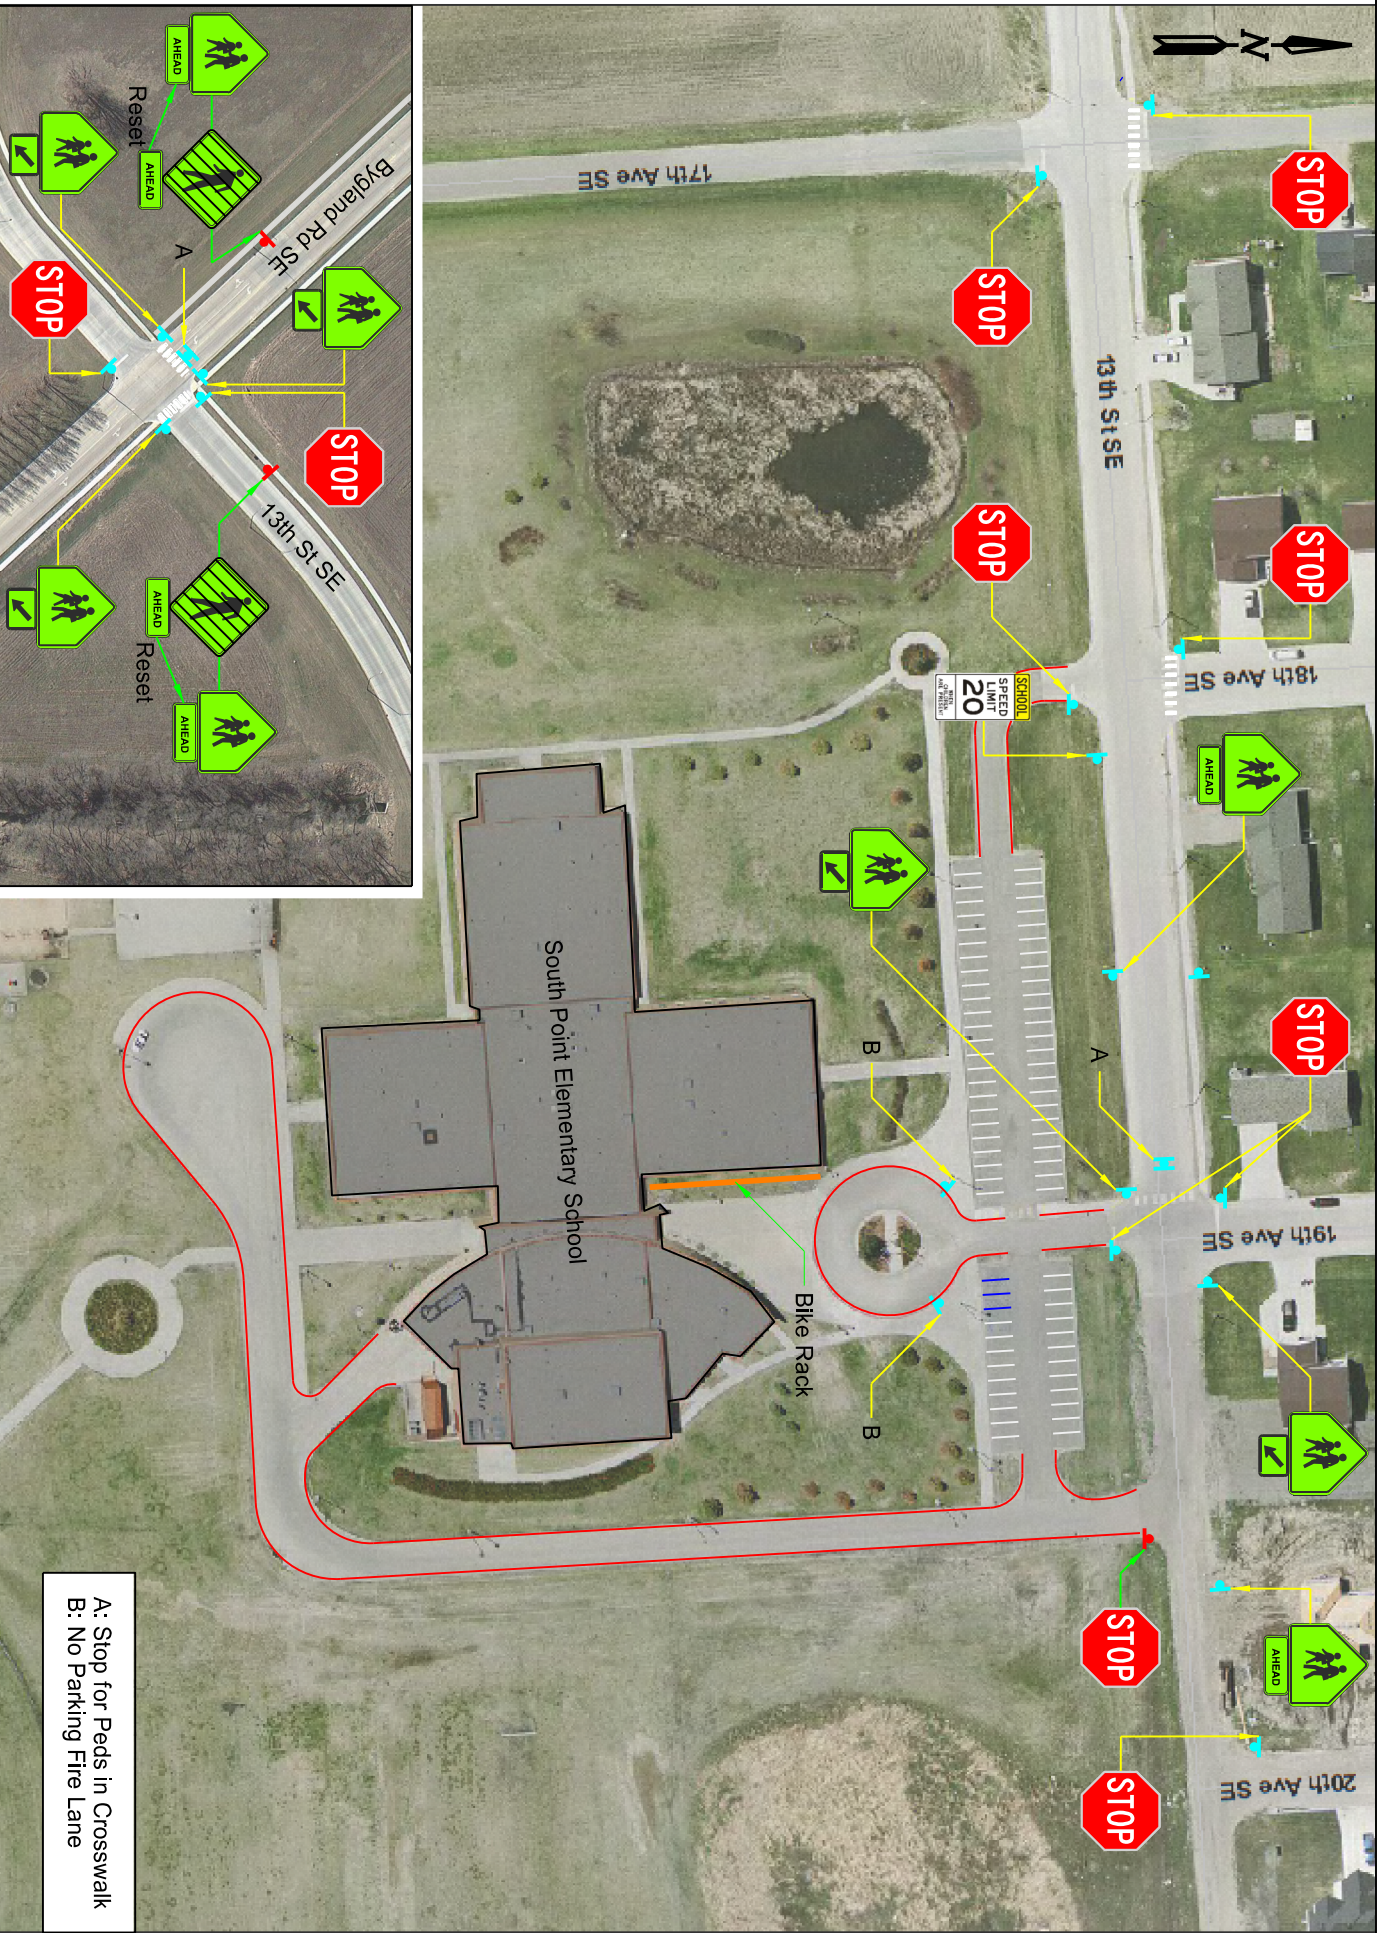
South Point Elementary: Proposed

A: Stop for Peds in Crosswalk
 B: No Parking Fire Lane

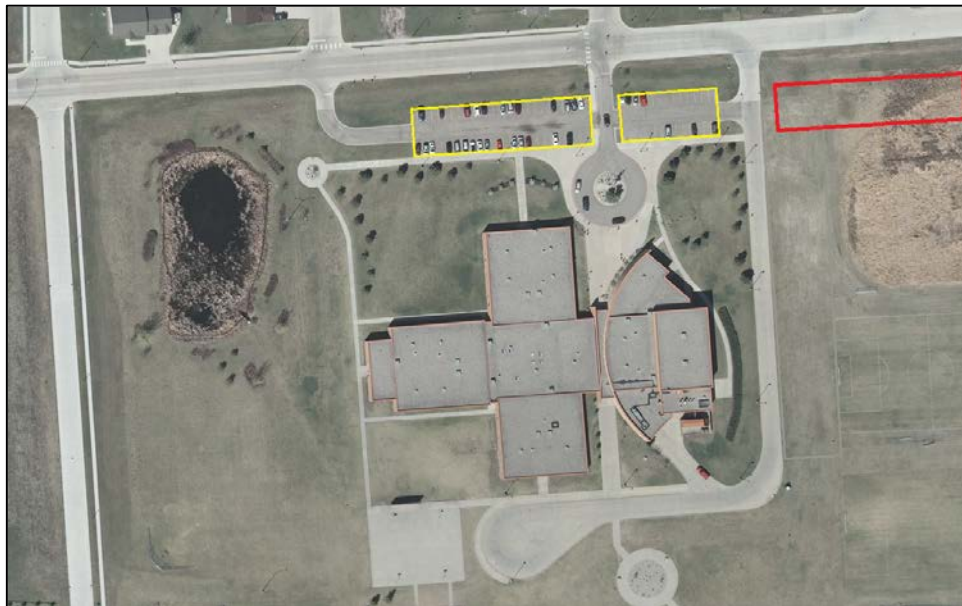
Figure 5.5 – South Point: Proposed Parking Lot Location

In order to accommodate the demand for parking spaces, addition of a parking lot is recommended. It is recommended that the new parking lot be located on the east side of the school premises as shown in figure 5.5 below.

It is recommended that the two west driveways, other than that currently being used by buses, be redesigned keeping in mind that they will be used for simultaneous exit and entry by passenger cars. The current throat width of the two driveways occasionally forces vehicles to stop/yield until the driveway has been cleared by the oncoming vehicle. The driveway leading to the circle in front of the main entrance should also be widened similar to the two driveways.
